Contour Repairs Nozzle on Thermal Oxidizer

Pipe Details

Summary

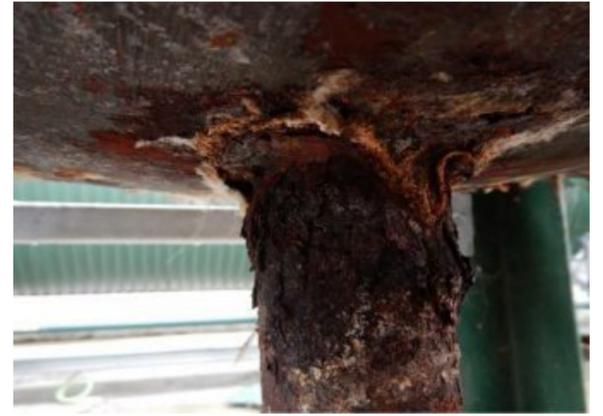
The corrosion covered 60 mm (2.36 in) from the connection to the lower head on a 50 NB schedule 80 nozzle, thinning the nozzle wall to approximately 1 mm (0.04 in) at its weakest point. The extent of the corrosion varied over this length, but the pipe was in sound enough condition to be repaired.

Severe corrosion on the nozzle of a thermal oxidizer knockout pot covered 60 mm (2.36 inches) from the connection to the lower head.
