Contour Restores Ammonia Tank Roof to Safety

South Korea

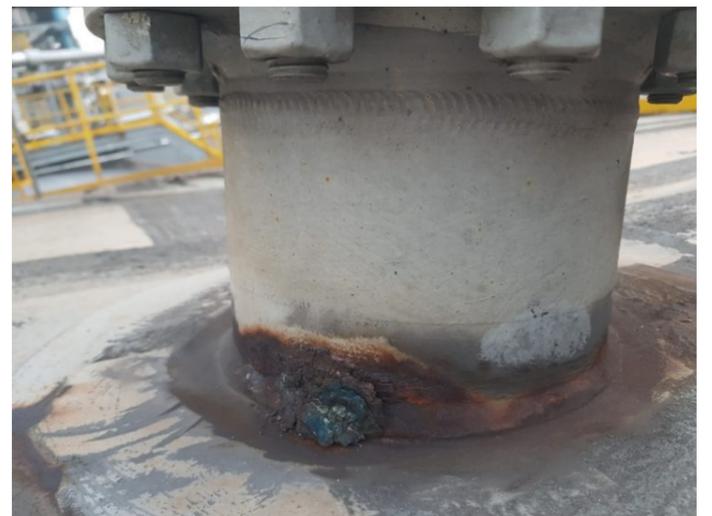
- Leaking ammonia tank
- Cracks from 1 mm to 5 mm (0.04 – 0.2 inch) on multiple girth welds
- 80°C (176°F) Operating Temperature

Girth Weld Damage

A team of 2 ClockSpring|NRI trained and certified installers from Dong-buk E&C approached this repair with caution, recognizing that the tank content was very hazardous and explosive. Because some points were leaking ammonia gas, the repair team used nitrogen dioxide to prevent an explosion while the weld joints were blast treated to ready the surface for the composite repair. When the preparation was completed, technicians filled each damaged area with proprietary filler before overlaying it with fiberglass. The complete repair required 2 layers of Contour.
