# Contour Restores Gas Line for 20 More Years of Service

### Pipe Details

- Two sections of an API 5L Grade B gas pipeline had suffered damage from external corrosion
- 50.8-mm (2-inch) diameter line was damaged over a 1,829-mm (6-ft) straight run of pipe
- 114.3-mm (4.5-inch) diameter line was damaged over a length of 2 m (6.56 ft) that extended along a straight run and an elbow
- Corrosion had caused wall loss up to 51% on both lines
- 75.8 bar (1,100 psi) design pressure
- 25°C (77°F) design temperature.

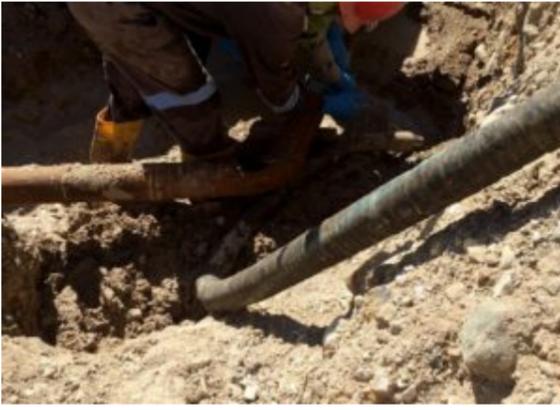
*When a number of saturated bands were prepared for application, the technicians placed them one at a time on the pipe, following a herringbone pattern (50% axial overlap).*

The epoxy and resin were mixed on site so the technicians could saturate one fiberglass band at a time using a paint roller. When a number of saturated bands were prepared for application, the technicians placed them one at a time on the pipe, following a herringbone pattern (50% axial overlap), taking special care to prevent any foreign matter from becoming trapped in the fabric and avoiding blisters, pits, wrinkles, pin holes, sagging sections (particularly on the bottom of pipe), and dry spots. When the appropriate number of layers were installed along the damaged areas, the Morken technicians placed a peel ply on top of the composite. The installation team completed the repair in only 3 hours.

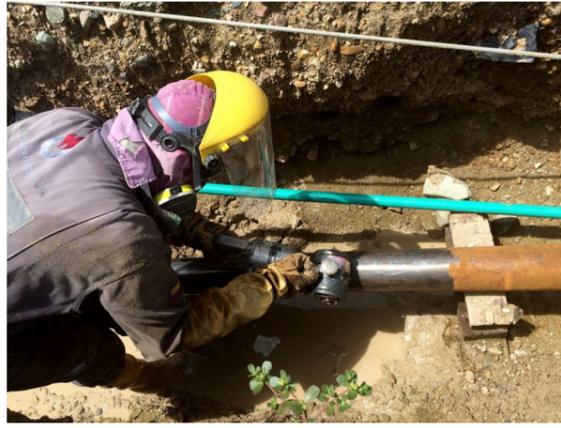
*A Morken technician uses a rotative reamer to obtain medium roughness (~ 3 to 4 mills) on the repair areas to provide an appropriate surface for the Contour repair.*

The first step of the job was to remove the coating from the pipes and prepare the surface. A rotative reamer was used to obtain medium roughness (~ 3 to 4 mills) on the repair areas to provide an appropriate surface for applying the composite solution. While the surface preparation was under way, a small table was set up and covered with plastic film to provide a work surface where installers would prepare the Contour for application on the damaged lines.

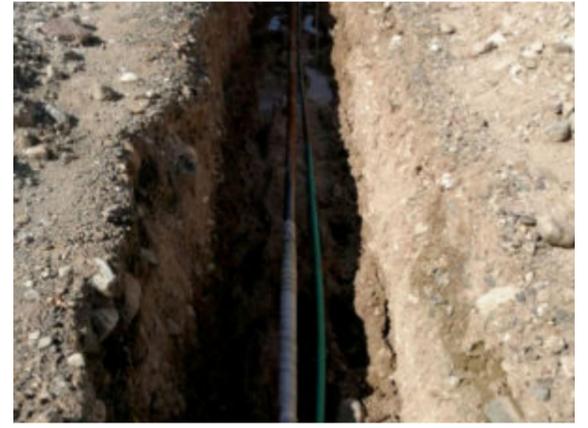
*Morken technicians placed a peel ply on top of the composite that remained in place while the composite cured to the appropriate hardness.*

Although the technicians allowed the peel ply to remain in place overnight, the repair cured to 74 Shore D hardness and was ready for service in approximately 5 hours.
