Contour Restores Integrity to Platform Drain Line

West Africa

Pipe Details

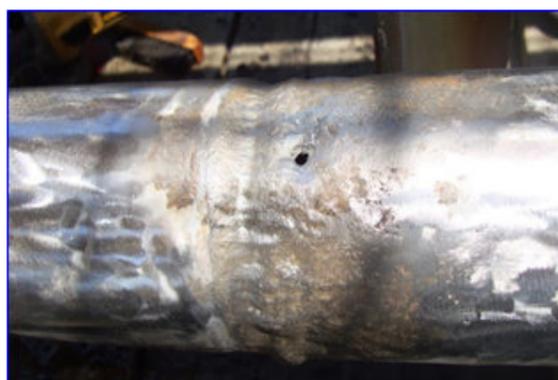
Corrosion was particularly bad at support locations and had created several through-wall defects, and the constant drip had created a large oil sheen on the surface of the water below. The line required an immediate repair that would ensure integrity and reduce environmental impact until the next planned shutdown.

Corrosion was particularly bad at support locations and had created several through-wall defects.

Clock Spring Company engineers designed a Contour repair in accordance with ISO 24817 guidelines, which provide requirements and recommendations for qualifying, designing, installing, testing and inspecting the external application of composite repair systems to corroded or damaged pipework, pipelines, tanks, and vessels used in the petroleum, petrochemical, and natural gas industries.

Clock Spring trained and certified technician removed the platform drain line supports and cleaned the spool sections using power tools to remove the pipe coating before applying a bristle blaster to achieve a surface profile equivalent to NACE#3/SA.2. With the pipe prepared for the installation, the crew applied a Clock Spring Contour repair.

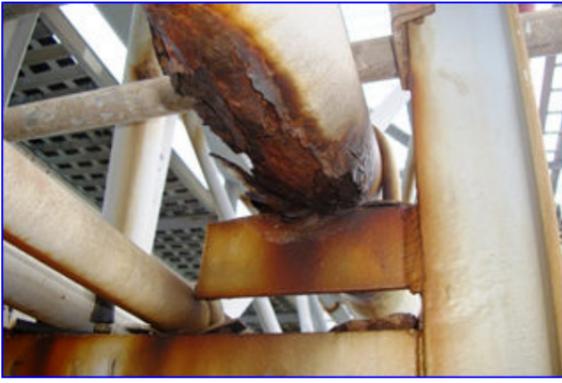
A routine inspection on an oil platform offshore West Africa revealed severe external corrosion on the 102-mm (4-inch) platform drain line located on a pipe bridge.

An oil platform offshore West Africa had severe external corrosion on the 102-mm (4-inch) platform drain line located on a pipe bridge.

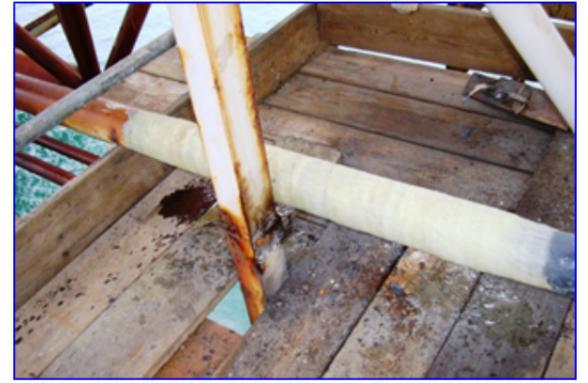
A team of 2 technicians completed the repair in 2 days, allowing the platform to continue operations safely until the next planned maintenance shutdown

Following standard installation procedures, 2 technicians executed the complete repair in 2 days, delivering a repair that would allow the platform to continue operations safely until the next planned maintenance shutdown, allowing the operator to resume production without the risk of additional environmental issues.
