Contour Restores Lines Damaged by CUI

Saudi Arabia

Pipe Details

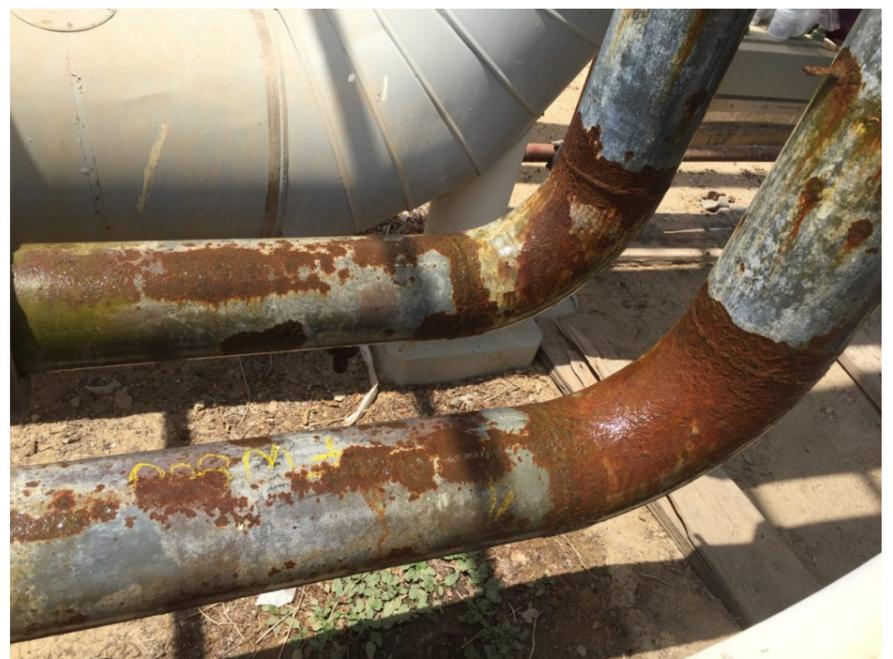
Corrosion under insulation is a problem in many operating environments and requires special attention. An owner of a pipeline terminal discovered a CUI problem in multiple areas on a 152.4-mm (6-inch) diameter Schedule 40 line carrying liquid styrene (vinyl benzene). Damage had compromised the integrity of 38 locations on the line, including elbows, girth welds, vents and drains that in some cases had experienced as much as 50% wall loss.

CUI was discovered in 38 areas on elbows, girth welds, vents and drains on a 152.4-mm (6-inch) diameter pipeline carrying liquid styrene.

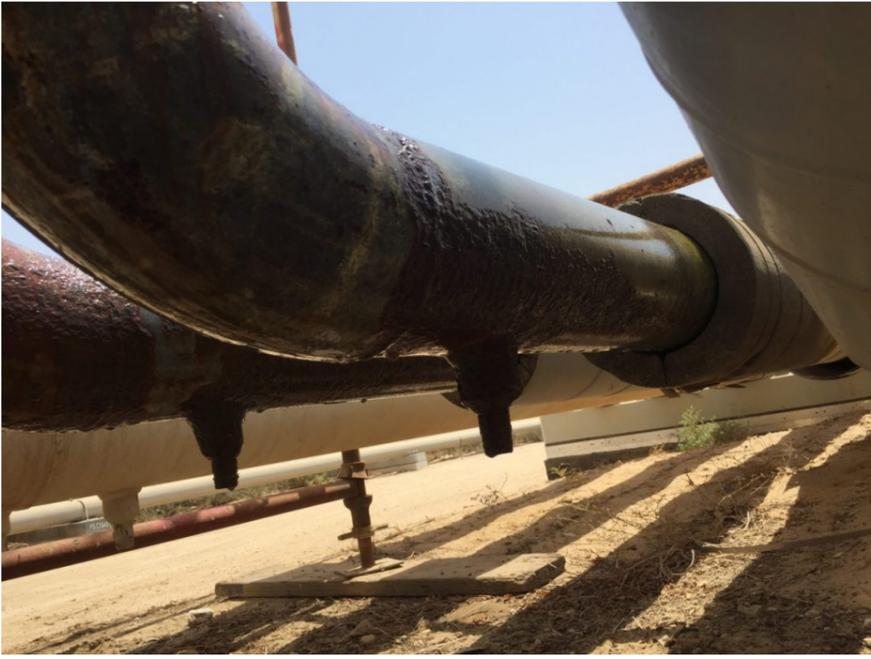
CUI damage was extensive, resulting in 50% wall loss in some areas.
