# Contour Safely Restores Leaking Valve

New Mexico

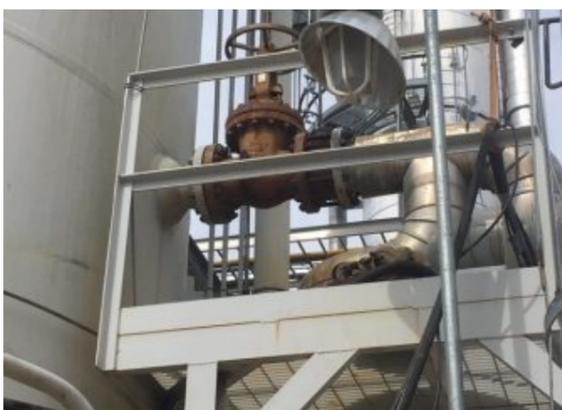
- 6-inch (152-mm) cast valve containing amine developed a pinhole leak measuring <0.25 inch (6.35 mm)
- 600 psi (41.3 bar) operating pressure
- 38°C (100°F) operating temperature

*The uniquely shaped leaking valve required the composite fabric to be measured and precut to ensure a proper fit.*

Clock Spring Company, Inc. provided the solution. A team of 2 Clock Spring trained and certified technicians used leak stop filler and a square patch of fiberglass to address the weeping leak while the system was online. Once the leak was safely contained, the technicians completed the repair, using fabric that had been measured and precut to ensure a proper fit on the uniquely shaped valve. Preparing the components in advance was especially important because of the confined work space around the valve.

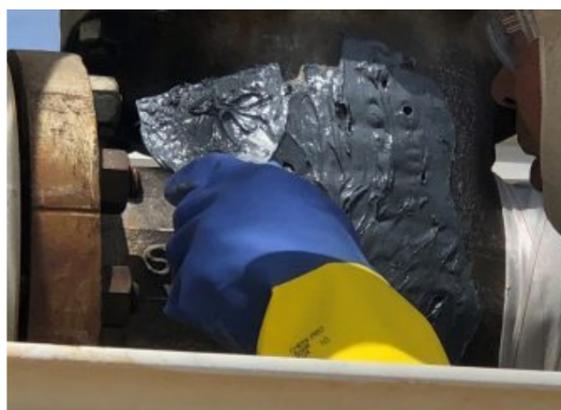
*A Clock Spring trained and certified installer applies filler to the valve.*

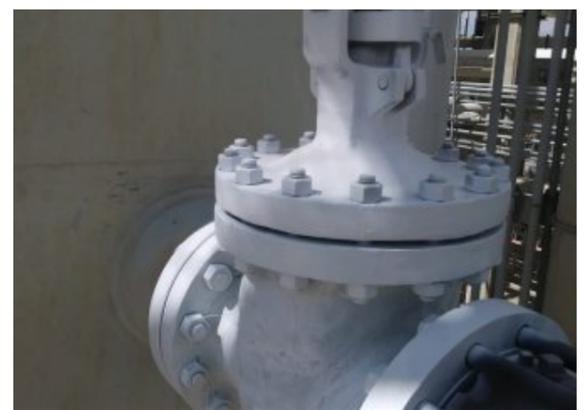
*A 2-man team completed the installation on the active line in approximately 4 hours, following up with recoating the next day.*

Following an established installation process, the 2-man team was able to prepare the damaged area and complete the installation on the active line in approximately 4 hours, following up with recoating the next day and saving the refinery from lost production that would have cost several thousands of dollars per hour.
