Contour Takes on External Erosion in Saudi Arabia Petrochemical Plant SAUDI ARABIA

Pipe Details

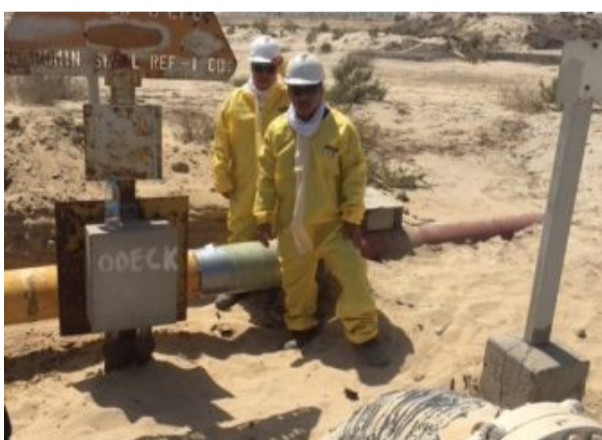
A team of Clock Spring trained and certified installers applied the Contour repair.

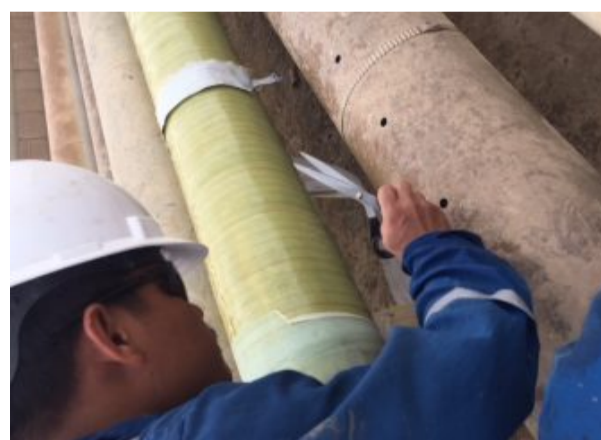
Working in tight quarters, an installer applies the Contour repair by hand.

Because the damaged pipeline was between other lines, access to the damaged area was tight. A team of 5 Clock Spring trained and certified installers prepared the pipeline for repair and applied the repair by hand, covering the areas with 8 layers of Contour following standard installation procedures.

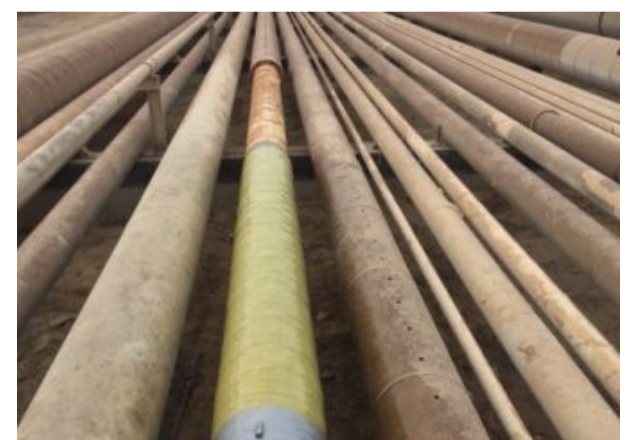
A team of installers completed a safe and reliable permanent repair in 2 weeks, restoring the line to safety without having to take it out of service.
