# DiamondWrap® HP™ 18" Wrinkle Bend Repair in USA

### Pipe Details

Pipe Diameter: 18"

Pipe Defect: 4 Wrinkle Bends over a 15-foot length

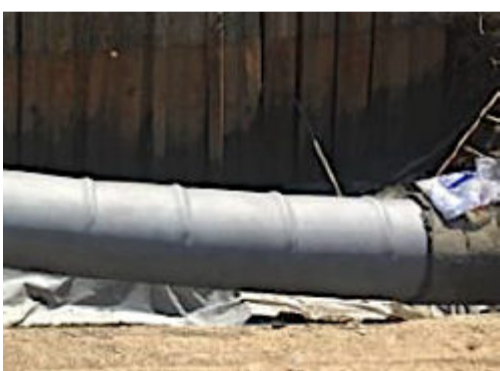
Inspectors for a natural gas pipeline operator in the USA found 4 wrinkle bends on an 18" gas transmission pipeline. The operator could not afford to shut down the line to cut and replace because of the high transport volume through the pipe. A welded sleeve could not be used because of the odd configuration of the anomaly. A picture of the anomaly is below.

Citadel Technologies' team of project engineers designed a repair for the wrinkle bend defect according to both ASME PCC-2 Article 4.1 and the testing that had been done at Stress Engineering, and recommended a DiamondWrap® HP™ repair solution. 12 total layers of a combination of Citadel's proprietary wrinkle bend repair fabric and the regular DiamondWrap® HP™ carbon fabric were required to repair the defect.

Citadel mobilized a trainer and materials to site within 24 hours to train the technicians that were to perform the repair. Once trained, the installers were able to complete the proposed repair within 3 hours, much quicker than other composite repairs available on the market, and with much higher quality and zero installation defects.
