# DiamondWrap® HTA™ 30" Flare Line Rehabilitation in Kuwait

### Pipe Details

Pipe Diameter: 30"

Pipe Contents: Flare Gas (H<sub>2</sub>S, NH<sub>3</sub>, HC)

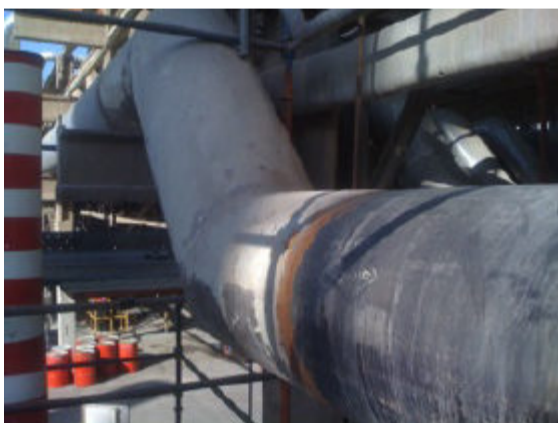
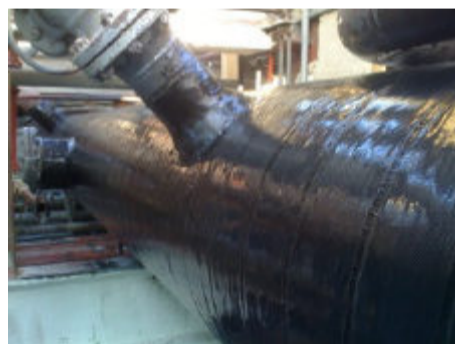
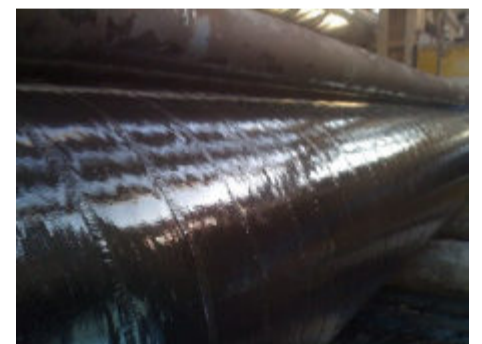
This flare line was suffering from internal pitting due to the harsh chemistries in the line. The pitting was primarily at the 6 o'clock, but extended midway up the walls. Pit depths were up to 3mm, and continuing uninhibited. The plant was at risk of shutdown if the corrosion continued and developed into a through-wall defect. The length of the corroded area extended over 50 meters, and encompassed straight runs, tees, and elbows.

Citadel Technologies' team of engineers designed repairs for each defect according to ASME PCC-2 Article 4.1, and recommended a DiamondWrap® repair solution. Only 2 layers of DiamondWrap® HTA™ were required to repair the defect.

A team of trained and certified installers installed layers of carbon fiber over the specified repair area, according to the calculations prepared by the Citadel Technologies engineer. No heavy equipment or hot work was required for the installation, and the line was in operation with no disruption in production. Below are photos of the completed repair:
