DiamondWrap® HTA Restores Bath Heater to Safe Service

Pennsylvania

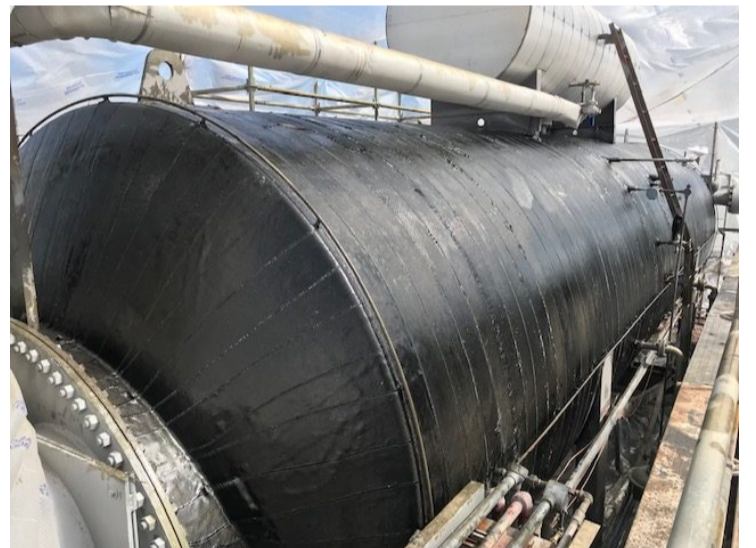
The flexibility and low profile of the DiamondWrap composite system allow installation even in areas with limited clearance. (Photo courtesy of ClockSpring|NRI)

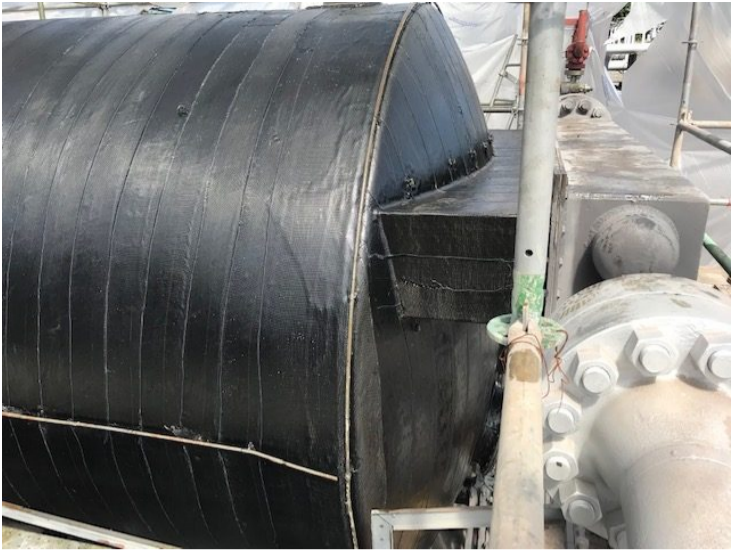
DiamondWrap can be installed on tees, elbows, and varied geometry without compromising the integrity of the repair. (Photo courtesy of ClockSpring|NRI)

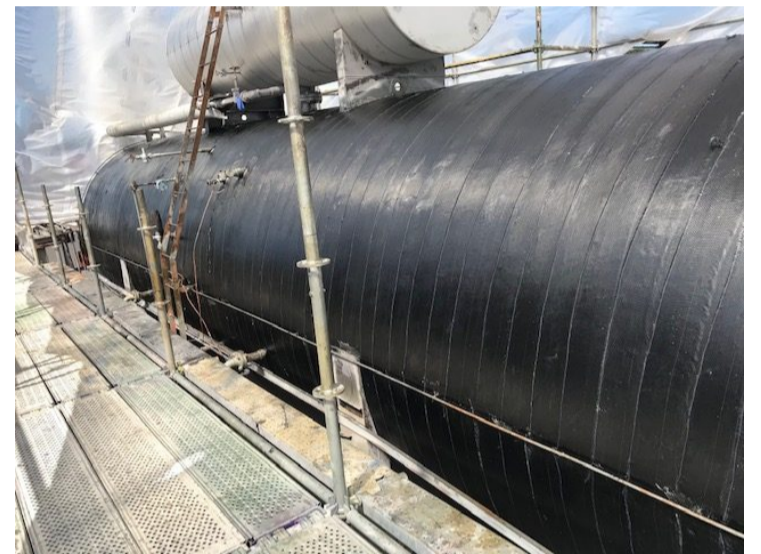
The composite system forms a pipe around a pipe, and each successive wrap increases the pressure rating, creating a finished repair that is stronger than steel. (Photo courtesy of ClockSpring|NRI)
