DiamondWrap® 18" Flare Line Repair in Singapore

Pipe Details

- Refining Company
- Ambient temperature to 80 C
- Pressure: 50psig
- Sulfur acid concentration 4% – 98% weight
- 18" pipe
- 100% assumed wall loss

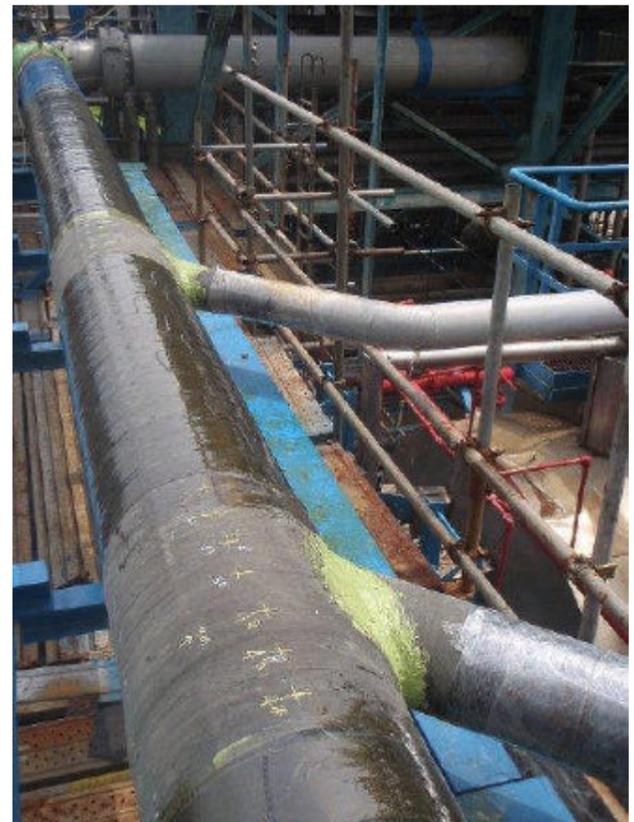
Application of the putty (Green color) at the Y-joints in preparation of the wrap. The grey area where it is not shiny with the yellow markings is the existing competitor wrap. The shiny areas are already wrapped with DiamondWrap.

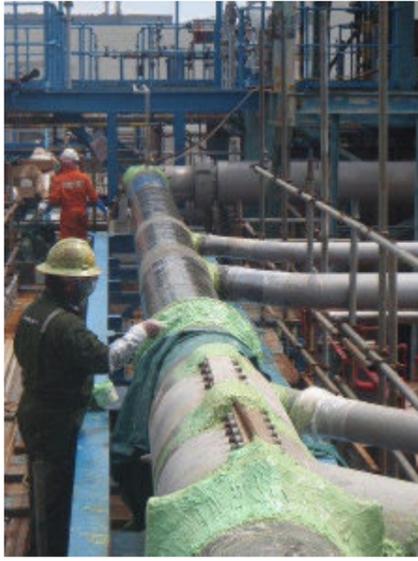
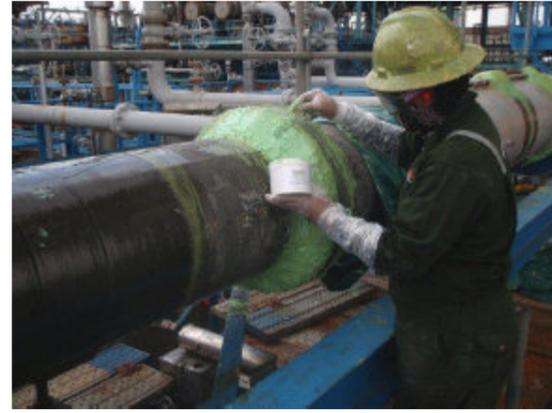
Application of putty in stages for the flange and the clamp.

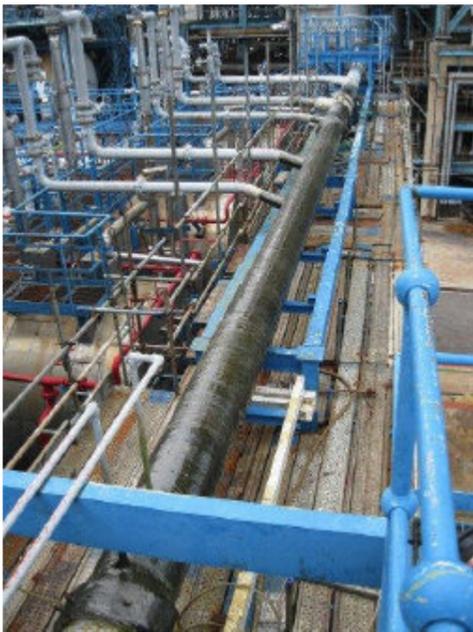
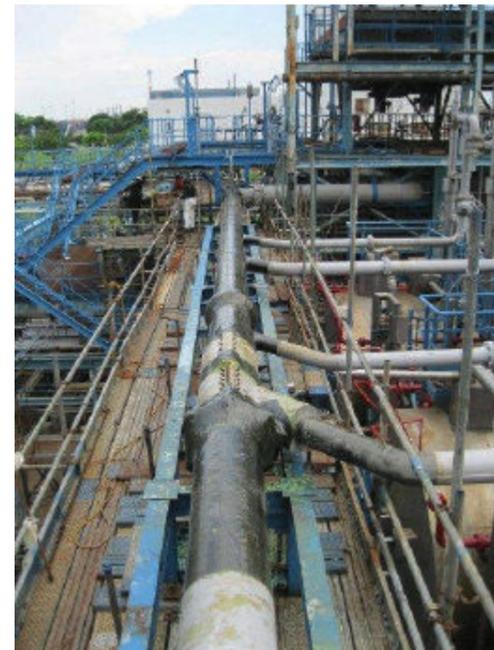
Job completed. Wrapping is to 8" onto the clamp on both ends where you can see on the picture on the right. The flange is being wrapped entirely and on the picture on the left, the wrap goes onto a clamp as well.
