DiamondWrap® – External Corrosion Patch Repairs in Ecuador

Customer: Tank Operator

Location: Ecuador

Tank Defect: External Corrosion

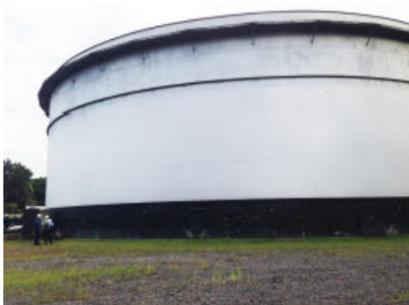
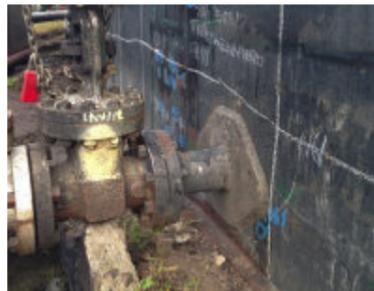
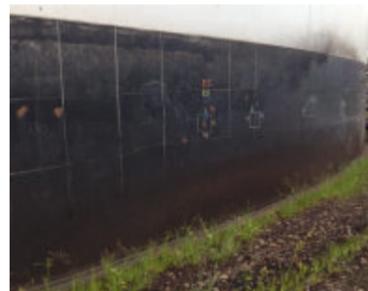
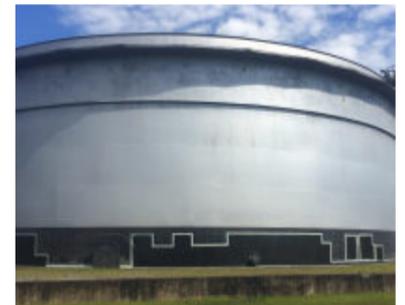
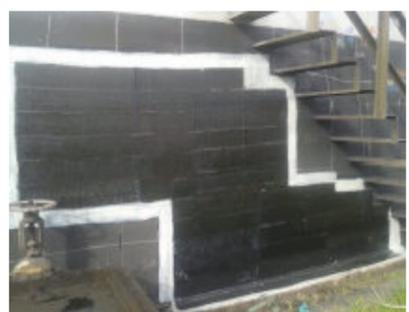
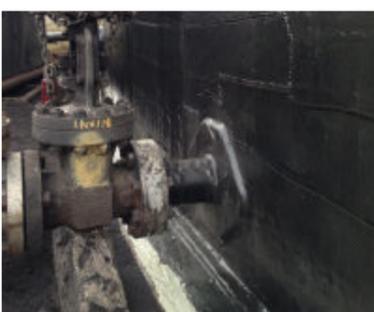
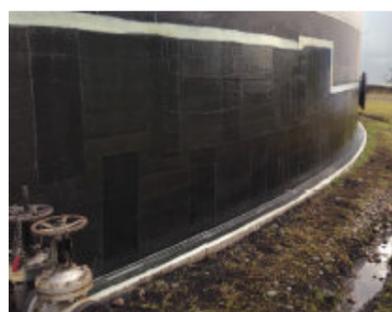
A terminal operator in Ecuador reached out to us about one of their floating roof tanks suffering external corrosion from ground moisture along several parts of the tank. Numerous points along the base of the tank upward about 6 to 8 feet had been identified as corroded areas needing repair. The environmental risk of leaking crude oil as well as a solution to stop further external corrosion led them to us.

Citadel Technologies’ team of engineers designed several patch repairs for each corroded area according to ASME PCC-2 Article 4.1, and recommended a DiamondWrap® repair solution. Utilizing equation 6 from the Article for repairing metal loss, Citadel’s engineers designed a conservative repair while optimizing the amount of layers and installation time.

A team of trained and certified installers layered carbon fiber over the specified repair area, according to the calculations prepared by the Citadel Technologies engineer. No heavy equipment or hot work was required for the installation, and the line was in operation with no disruption in production. Below are photos of the completed repair:
