Offshore Composite Repair Strengthens Riser Supports

MIDDLE EAST

Pipe Details

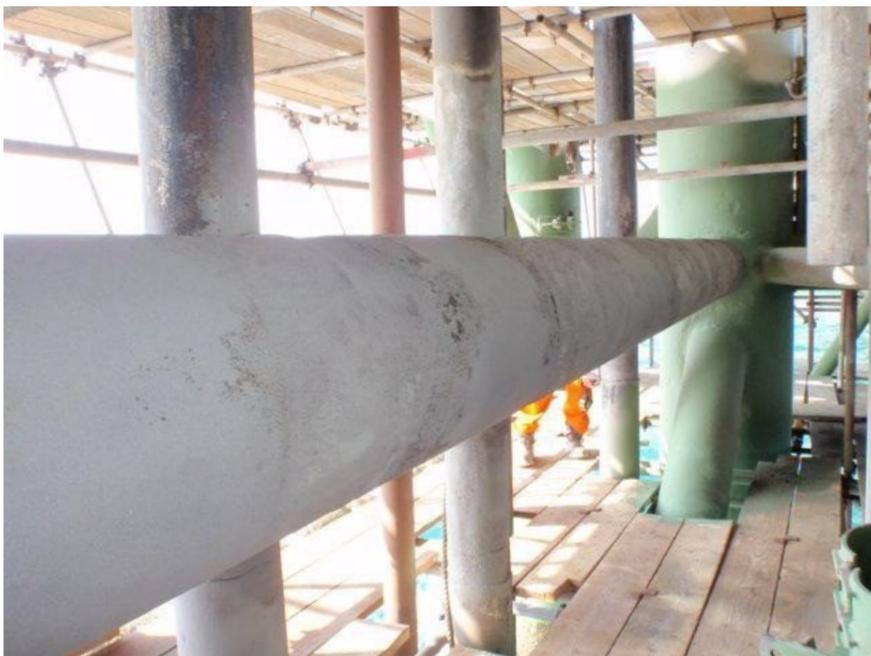
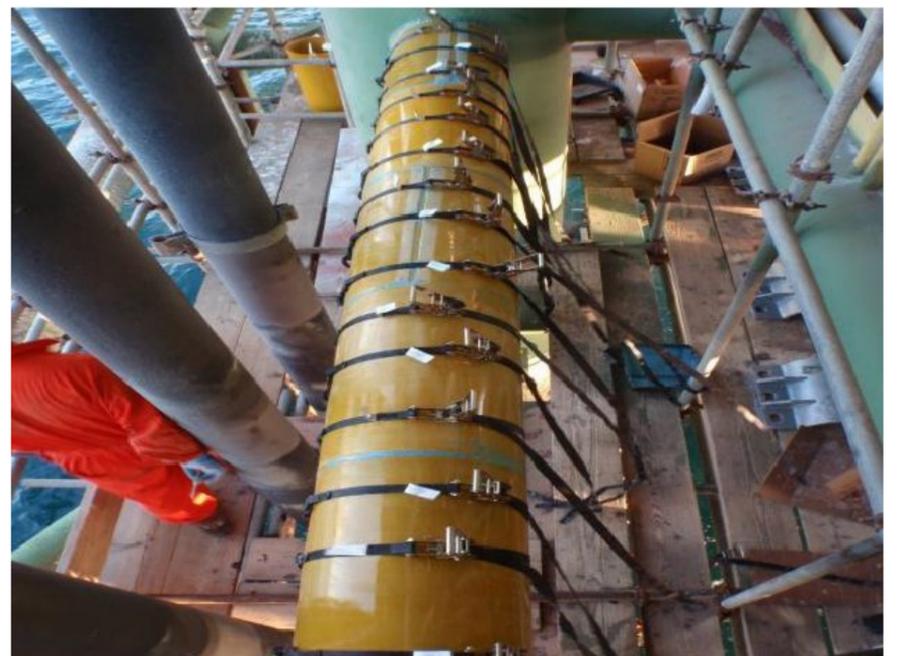
The 610-mm (14-inch) heavy wall structural cross member exhibited damage across a length of 8 m (26.25 ft). Severe external corrosion, which in some cases amounted to 80% metal loss on the structural member designed to hold the riser support clamps, was jeopardizing the safe execution of hydrocarbon production. The company needed a solution that could be carried out offshore in a short time frame with little disruption to its operations.
