# Offshore HP Separator Leak Stopped with Contour

WEST AFRICA

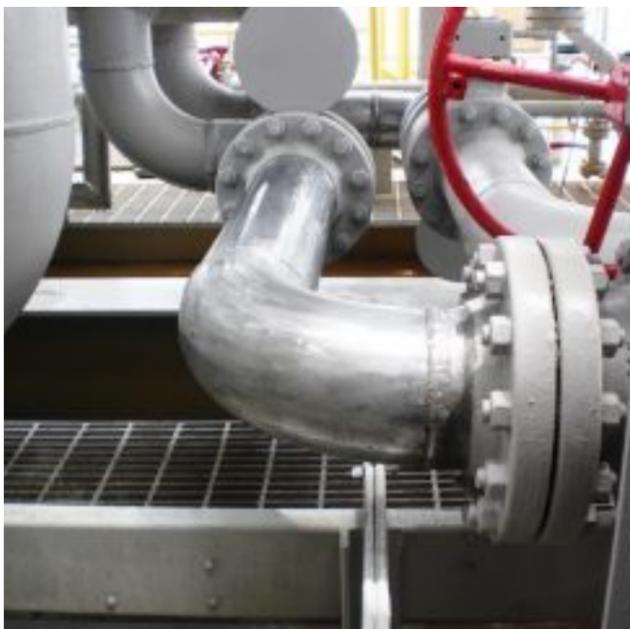
*Two Clock Spring trained installers cleaned the spool sections using power tools to remove all coating, then bristle blasted the surface to achieve a profile equivalent to SA2.5.*

Two Clock Spring trained installers cleaned the spool sections using power tools to remove all coating, then bristle blasted the surface to achieve a profile equivalent to SA2.5. With the outlets prepared, the team installed the Contour repair, designed in accordance with ISO 24817 guidelines, which provide requirements and recommendations for qualifying, designing, installing, testing

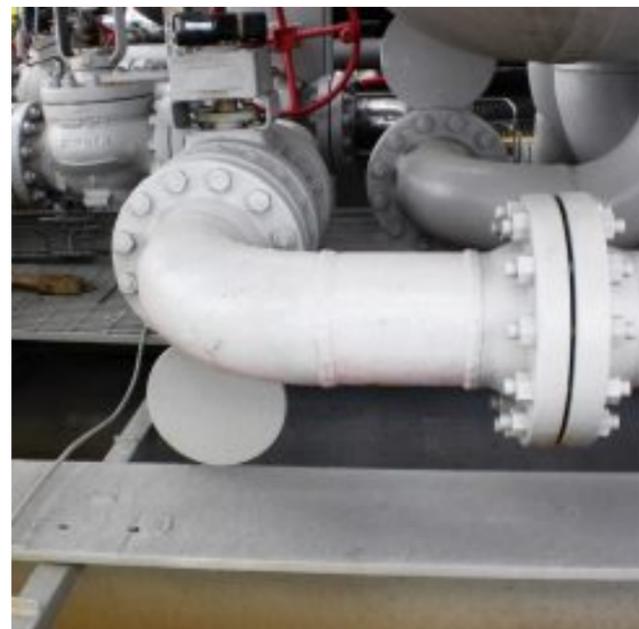
The erosion was growing at such a rate that imminent failure was likely. It was imperative that repairs be made immediately to avoid shutting down the platform, resulting in huge loss of production.

*UT inspection revealed severe internal defects on the 152.4-mm (6-inch) outlet of the main HP oil/gas separator on an offshore platform.*

The solution was to apply a Clock Spring Contour repair, an engineered wet-applied system that uses bi-axial or quad-axial stitched fiberglass cloth applied with two-part epoxy and a filler material. A Contour repair could be carried out without taking the line out of service, delivering a temporary reinforcement to allow production to continue safely until the next planned shutdown.

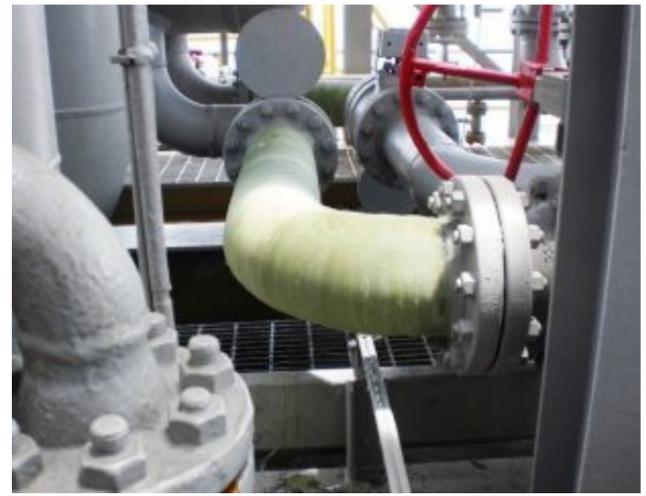
*The completed repair was carried out in a single day without shutting in production, returning the line to safe service until the next scheduled shutdown.*

The completed repair was carried out in a single day without shutting in production, returning the line to safe service until the next scheduled shutdown.
