# Thermo-Wrap Inspectable Restores Offshore Platform to Safety

711-mm (28-inch) pipe tee section on an offshore platform

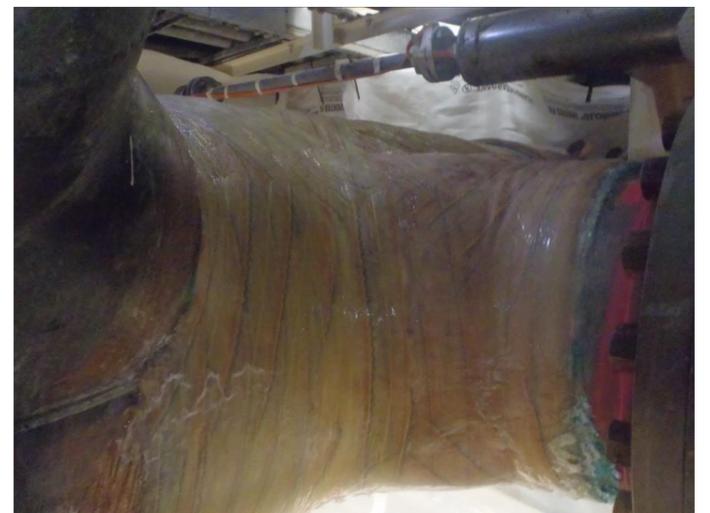
*The repair executed by the original solution provider failed to arrest the leaks in the high-pressure line.*

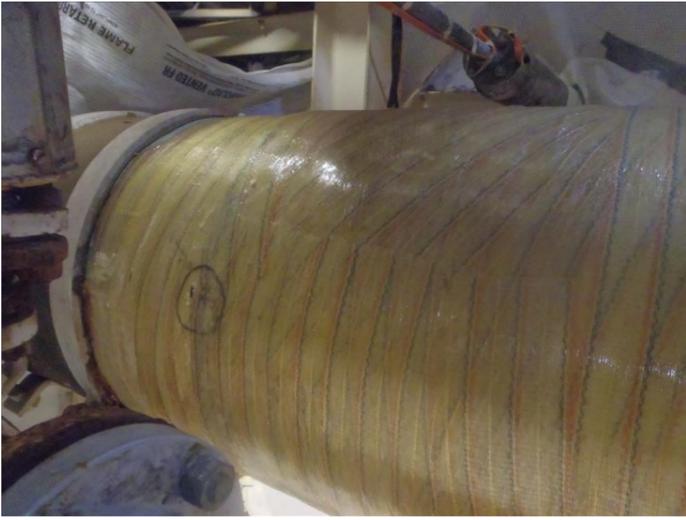
One of the difficulties for the engineers designing the composite system was making sure it would address the shortcomings of the existing failed repair. Technicians had to trim back the faulty repair before the CSNRI solution could be installed. When they did so, they discovered several leaks on the active line that had to be sealed live before the CSNRI repair could be carried out. By removing the original repair, the installation team was able to ensure all the leaks were arrested, and without the unwieldy repair in place, they were able to deliver a smaller repair that was faster to apply.

*Leaks in the original repair had to be addressed before the CSNRI solution could be installed.*

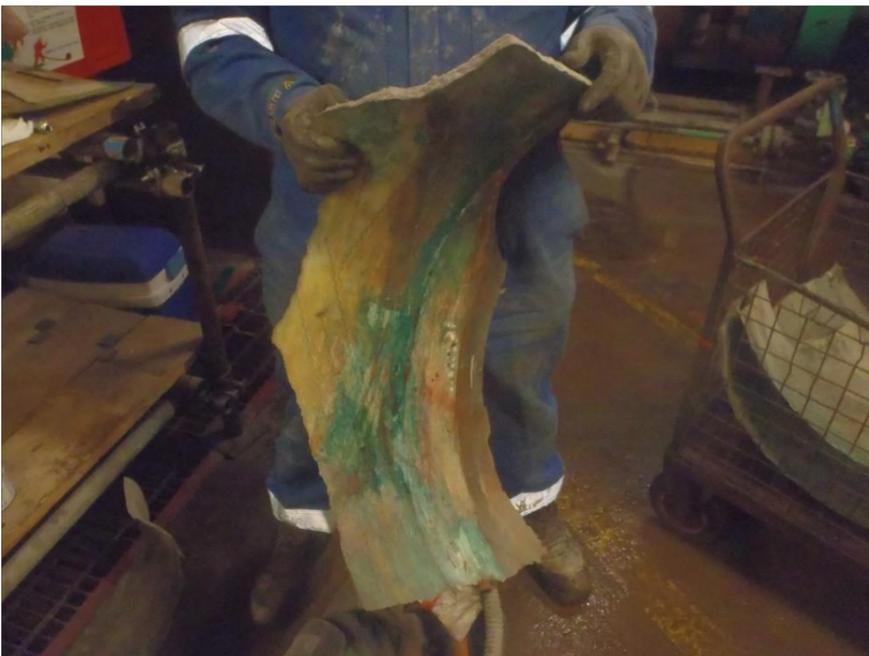
*Technicians trimmed back the faulty repair and addressed multiple live leaks before installing the Thermo-Wrap Inspectable composite system.*

A team of 2 trained technicians carried out the installation over the course of 4 days, sealing multiple live leaks with the proprietary composite injection system in an area with tight access and overwrapping the repaired segments of the line with the Thermo-Wrap Inspectable composite repair.
