Thermo-Wrap™ Inspectable Restores FPSO to Safe Operations

ANGOLA

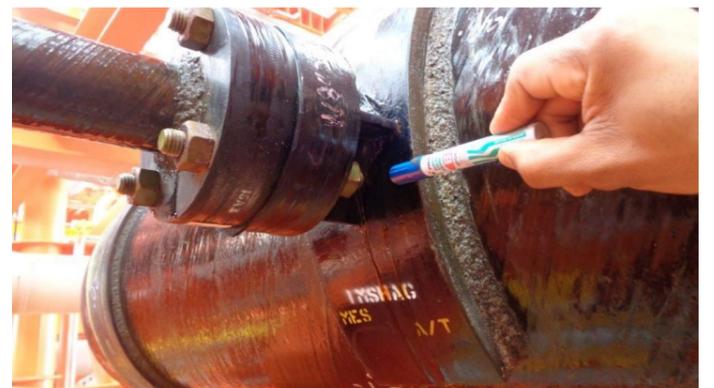
A leak is detected on a joint between a 508-mm (20-inch) and 51-mm (2-inch) GRE branch line.
