## Composite Sleeves Restore Gas Pipeline Integrity in Gujarat

By **K.P. Radhakrishnan**, Deputy General Manager (O&M), **GSPL**, **Andrew Patrick**, Executive Vice President Global Sales, **Clock Spring**, and **Bidyut B. Baniah**, Chief Project Manager, **Allied Engineers**

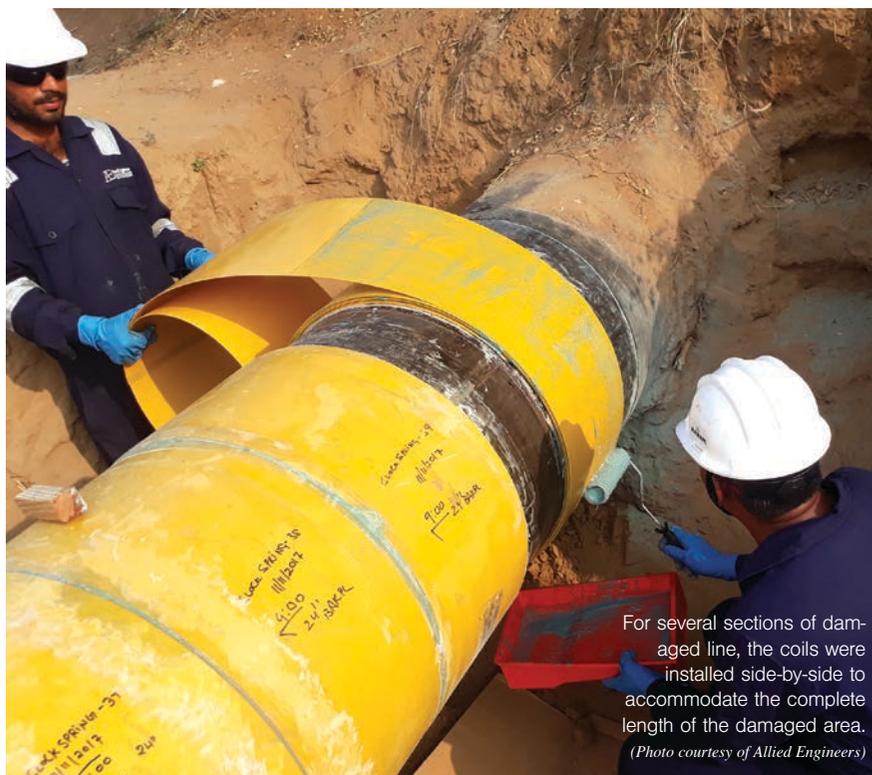
For several sections of damaged line, the coils were installed side-by-side to accommodate the complete length of the damaged area. (Photo courtesy of Allied Engineers)

Once the coil was wound around the pipe and adhesive was applied to the complete surface area of the coil, installers slid the sleeve into place onto the starter pad. In multiple places along the repaired line, the composite units also were placed over girth welds to provide a complete repair solution for the entire length. For several sections of damaged line, the coils were installed side by side to accommodate the complete length of the damaged area.

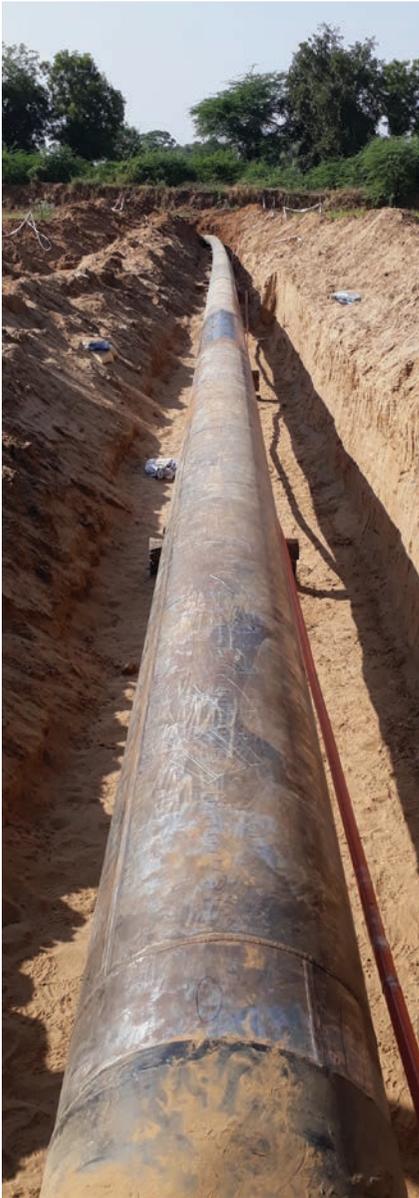
The initial pipeline excavation covered 22 meters (72 feet) and included the pipeline ROU.

Arrangements were made to excavate the line where the unauthorized excavation had taken place. The GSPL operations and maintenance team oversaw the initial manual excavation activity near the town of Asarma, where pipeline depth coverage was only 60 cm (24 inches) for an 80-meter (263-foot) segment of pipe. The initial pipeline excavation covered 22 meters (72 feet) and included the pipeline ROU, so additional manpower was allocated to the project to manage the expanded scope.

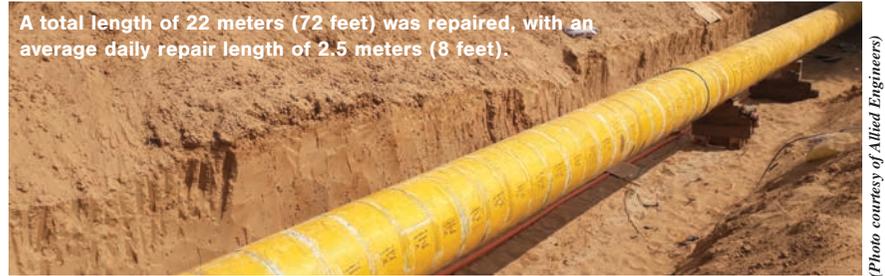
A total length of 22 meters (72 feet) was repaired, with an average daily repair length of 2.5 meters (8 feet).

A total length of 22 meters (72 feet) was repaired, with an average daily repair length of 2.5 meters (8 feet) and a maximum repair in a single of 4.5 meters (14.5 feet). The accelerated repair timeline allowed the pipeline operator to assure the original strength of the pipeline was

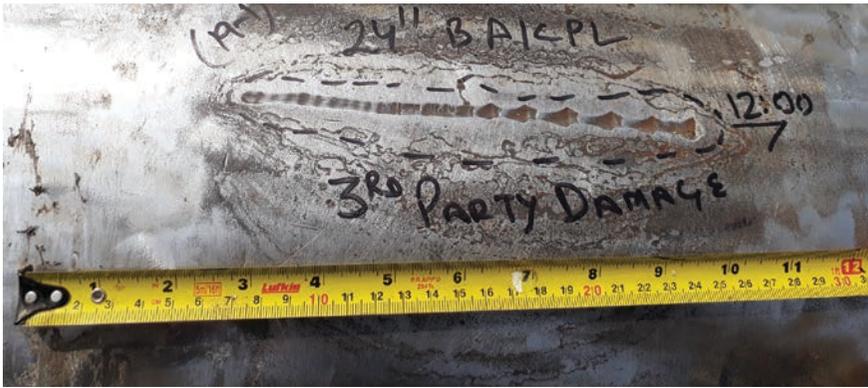
With the line excavated, the inspection team noticed dents in the pipeline and began the process of removing the polyethylene coating on the line. As the remediation team removed the damaged coating, they uncovered more damage on another section of pipe. Eventually, 26 areas were identified where there were minor dents in the pipe and 2 to 3 mm (0.08 to 0.12 inch) metal loss in the form of gouges on the surface of the line.

With more information in hand, GSPL was able to quantify damage. An 80-meter (263-foot) segment of longitudinal submerged arc welded (LSAW) pipe coated with impressed current cathodic protection in the form of three layers of polyethylene exhibited dents and more than two dozen areas of 2 to 3 mm (0.08 to 0.12 inch) metal loss in the form of gouges that needed to be repaired.

When the survey was concluded, engineers had identified 26 areas with minor dents (Photo courtesy of Allied Engineers)
