Composite Repair Takes on External Corrosion at a Chemicals Factory

Australia

Pipe Details

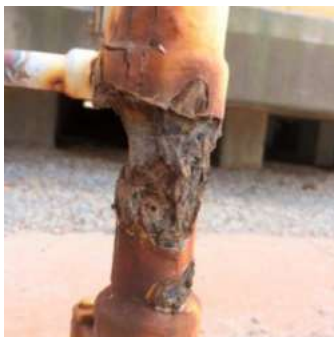
Inspections at a chemicals factory revealed significant corrosion on a 25-mm (1-inch) diameter API 5L Grade B steel pipeline with 3.9-mm (0.15-inch) wall thickness designed for 4 bar (58 psi) pressure and temperatures of 40° C to -40 °C (104° F to -40° F) that was transporting ammonia. When the corrosion was identified, the wall thickness had eroded to 1 mm (0.04 inch).

External Corrosion

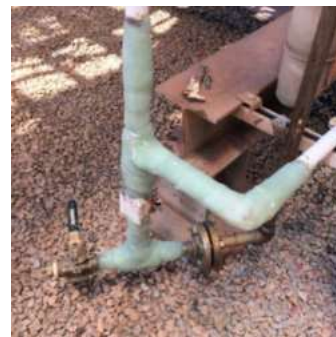
Completed Repair

The surface of the pipe was prepared using hand tools followed by solvent to remove dust, grease and any oil deposits. A trained and certified installer completed the repair within 3 hours. The line was in normal service throughout the repair installation.
