Contour Repairs Pitting on a Jetty

United Kingdom

Pipe Details

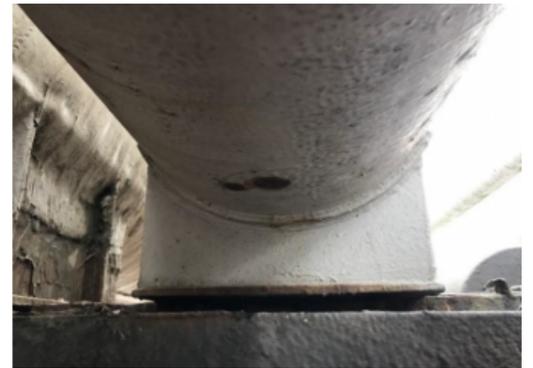
A planned inspection of a 457-mm (18-in) gas oil line on a jetty at a UK terminal uncovered a pit on a gas oil line.

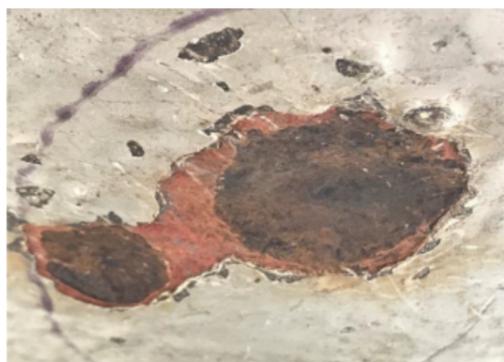
During a planned routine inspection of a 457-mm (18-in) gas oil line on a jetty at a UK terminal, the company discovered a 6-mm (0.24-in) pit that left only 24% wall thickness remaining. An engineering assessment to the local assessment code confirmed a repair was required for the line to remain fit for service.

The damaged line had developed a 6-mm (0.24-in) pit that left only 24% wall thickness remaining.
