AVT™ EZ VALVE®

EZ Valve Restores Ruptured Water Main to Safe Service

CASE STUDY: Wyoming, Michigan

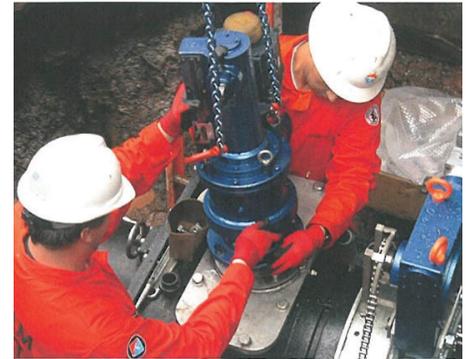
Alterations to the EZ Valve allowed installation on the irregular dimensions of the old cast iron main.

The compact valve profile allowed for a smaller excavation than other valve systems, and because costly restraint operations were not required, only one excavation was needed. Unfortunately, the installation began with a setback. The irregular dimensions of the old cast iron main required alterations to the valve fittings on the EZ Valve so it would work properly on the cast iron main. Meanwhile, weather conditions had deteriorated, with gusting wind and temperatures well below freezing.

Despite these challenges, the team was able to install a 16-inch (400-mm) insertion valve. The extra on-site work added about 1.5 hours to the process, but the valve installation that followed took only 4 hours. With the valve in place, municipal workers could begin making repairs.
