PROJECT OVERVIEW

Application: CMP Culvert Repair

Location: River Road, Weldon, NC

Client: North Carolina DOT

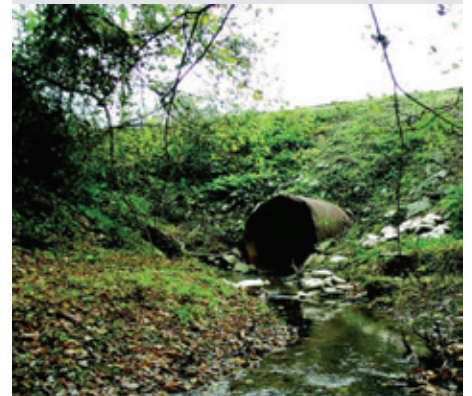
The NCDOT was faced with significant issues of culvert failure and bank erosion.

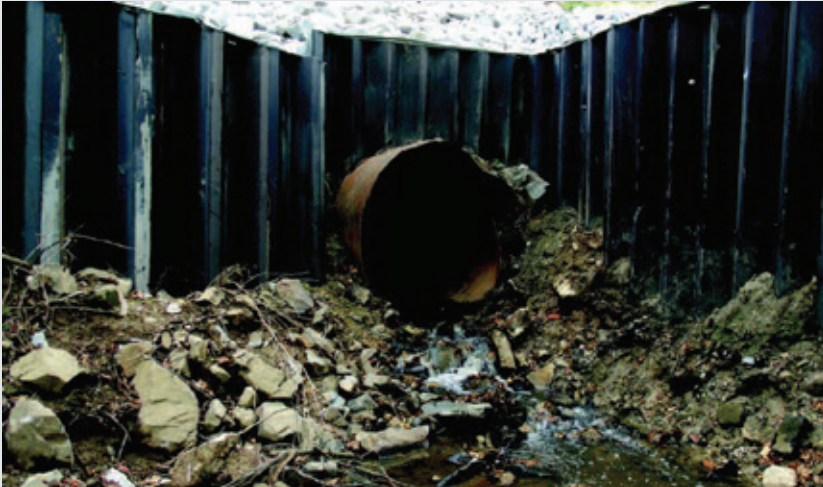
Head wall of pipe on river outfall.

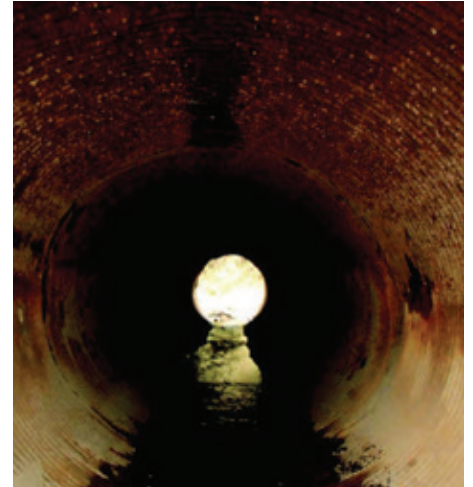
Initial pipe condition with significant invert corrosion.

- Day 1 :** Set up 8-inch hydraulic by-pass system.
- Day 2:** Pressure wash and clean the pipe, and investigate for water infiltration.
- Day 3:** Hand-spray GeoSpray mortar on the invert to stop water infiltration and smooth CMP corrugations.
- Day 4:** Apply first two passes of GeoSpray mortar.
- Day 5:** Apply 3rd pass of GeoSpray mortar to build thickness to 1.5 inch and repair small water filtration leaks.
- Day 6:** Apply 4th pass of GeoSpray mortar.
- Day 7:** Complete final pass to reach requested 2.5 inch thickness, hand trowel any imperfections and remove by-pass system.

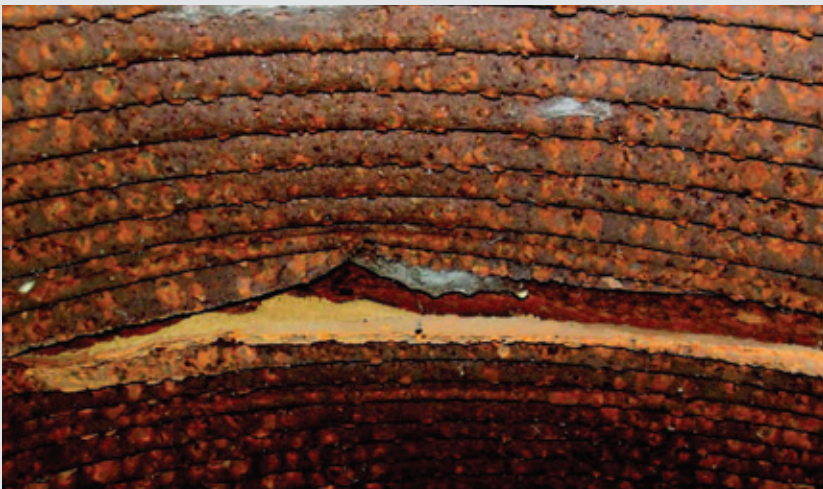
Initial conditions - pipe joint separation.

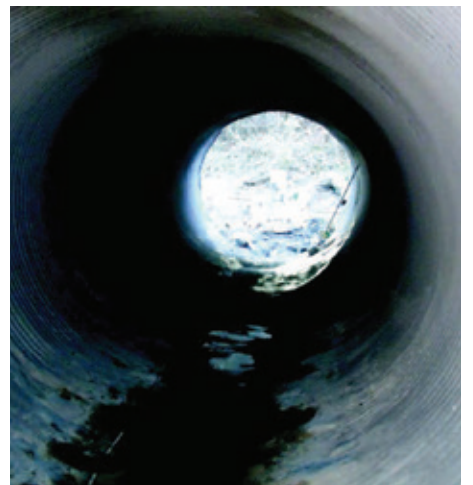
Completed culvert rehabilitation.
