PROJECT OVERVIEW

Application: Corrugated Metal Storm Sewer

Client: City of Conroe

Location: The Community of Walden on Lake Conroe

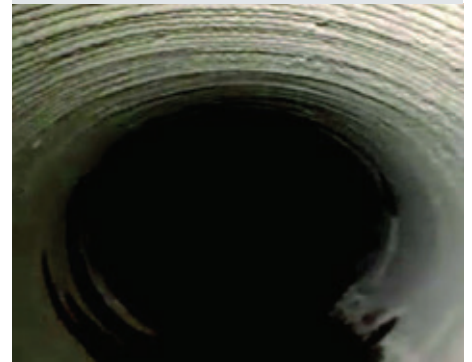
Completed liner using GeoSpray mortar.

The GeoSpray mortar lining was installed using the centrifugal casting method in three 1/2 inch passes. A single pass of the line took less than 2.5 hours to complete and all three passes were completed within 12 hours. The by-pass was released in under 24 hours and the new monolithic structure was completed.

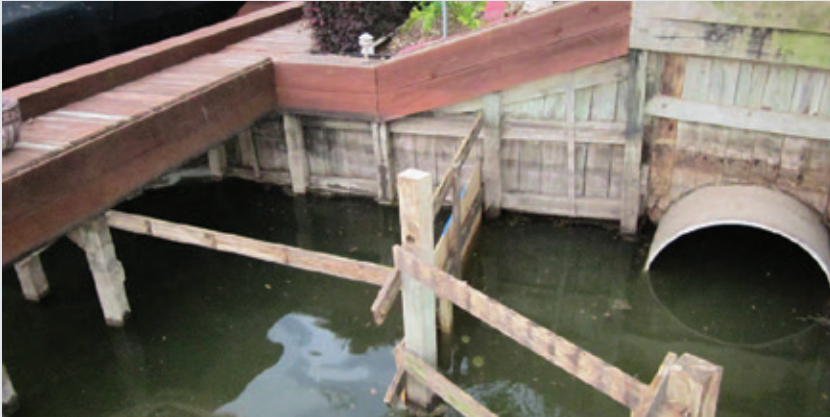
Outfall pipe, ending in Lake Conroe, was collapsed and replaced.

To begin the process, a new section of the pipe was added at the end of the outfall where the original pipe had completely corroded and failed. Once this repair was complete, the outfall end of the pipe was plugged to prevent ingress from the high lake level.

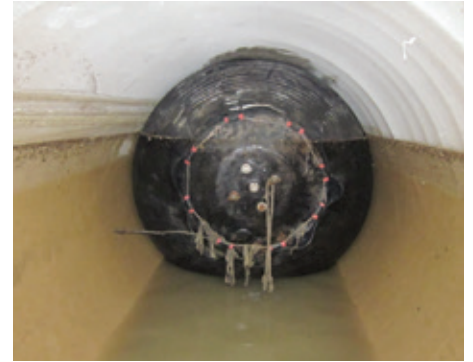
Outfall was plugged to prevent inflow of water from the lake.

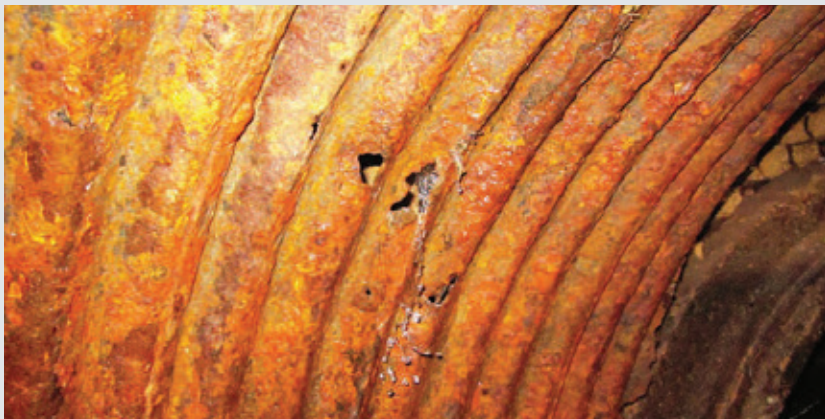
Heavy corrosion and infiltration within the pipe.

After the pipe was cleared of water and the damaged section by-passed, the contractor cleaned the pipe with a high pressure water treatment. After cleaning, several of the small holes in the pipe were plugged with GeoPlug™ rapid-set mortar to stop active infiltration.

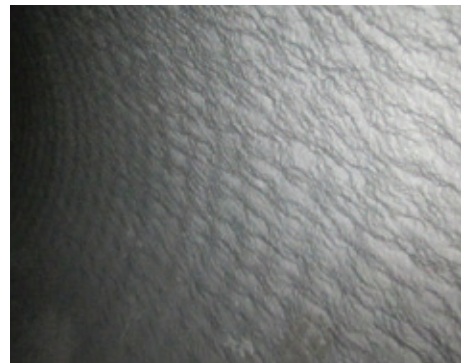
Close up view of sprayed geopolymer liner.

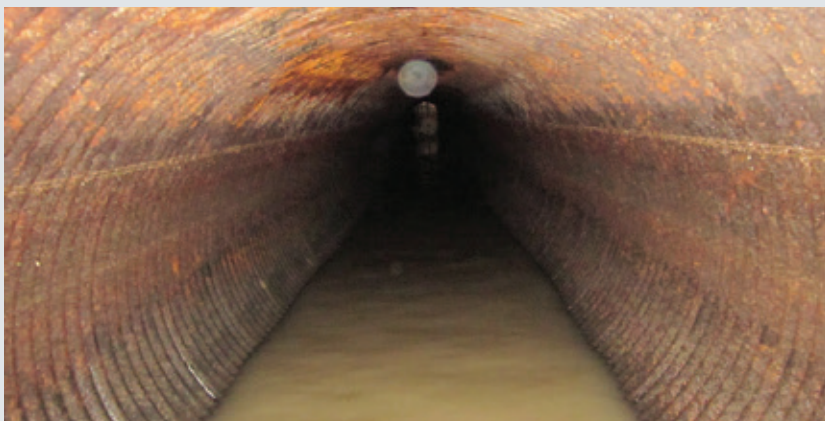
The community of Walden on Lake Conroe had been experiencing significant growth and the water infrastructure had begun to feel the burden. A 130 linear foot corrugated metal pipe (66 inches in diameter) that conveyed storm water from a local thoroughfare into the lake was severely deteriorated over most of its length with a section closest to lake having completely collapsed. When the city of Conroe began to look at options to repair the structure, it quickly eliminated the possibility of excavation and replacement of the pipe because its location and diameter would have likely endangered two neighboring residences. So the city decided that a trenchless rehabilitation would have to be the solution.

Severely deteriorated 130-foot CMP.
