PROJECT OVERVIEW

Application: Culvert Lining

Client: Henrico County
Department of Special Services

Location: Byrdhill Rd; Henrico,
VA

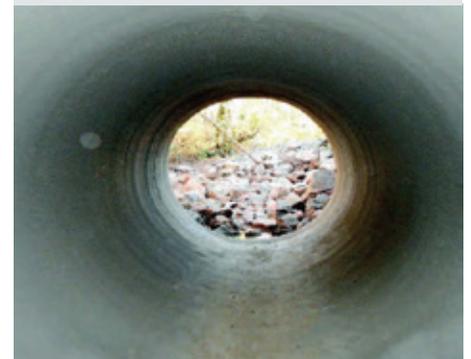
Completed culvert lining with GeoSpray mortar.

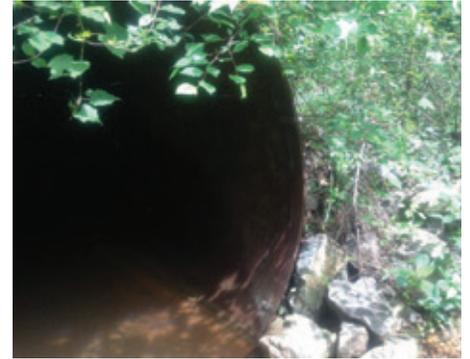
In early 2013, Henrico County, Virginia, identified a 120-linear foot section of 66-inch steel culvert running under Byrdhill Road in need of structural repair. The pipe was approximately 25 feet under the road and was suffering from severe rust and corrosion that is common in metal pipes over 25 years old. While the pipe was still structurally sound, the county was concerned about long-term life, so it took preventative measures to create a new structural pipe that would meet the water conveyance needs for decades to come.

View of the existing pipe outlet.

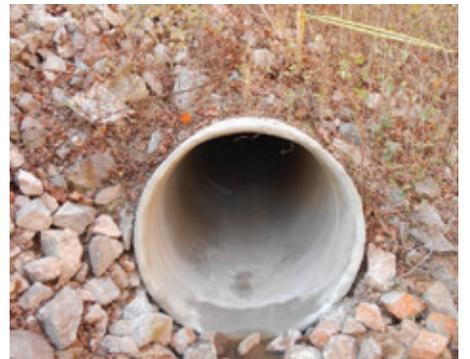
External view of the completed downstream outlet rehabilitation.

As a final clean-up measure, exposed areas of the exterior pipe were also coated with GeoSpray geopolymer to prevent further deterioration and present a homogenous appearance.

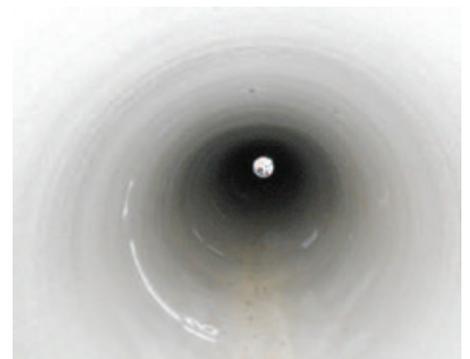
Upstream view of the completed repair.
