PROJECT OVERVIEW

Application: Highway Culvert

Client: Indiana DOT

Location: Peru, IN

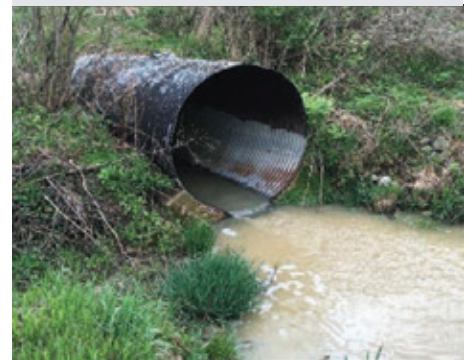
The 78-inch CMP culvert had a cracked and worn invert that showed severe ovality.

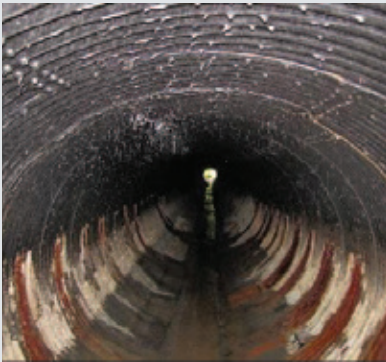
Initial pipe conditions were extremely poor.

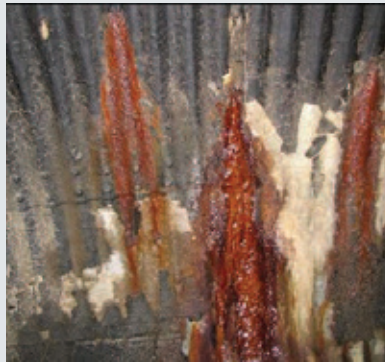
The pipe had severe infiltration, some ovality and a previous asphalt coating.

The active flow through the pipe could not be by-passed around the busy highway. An internal by-pass pipe was set up at the center of the pipe invert so that the pipe could be dewatered and the geopolymer could be applied without flowing water. First, the pipe was prepared by cutting any hanging or loose sections of the existing asphalt coating. Then it was pressure washed to remove loose debris. The pipe had a few areas of infiltration near the springline under the highway median that were plugged using hydraulic cement and a water-activated grout.
