PROJECT OVERVIEW

Location: Garyville, LA

Application: Industrial Manhole Rehabilitation

CASE STUDY: Garyville, LA Industrial Manhole Rehabilitation

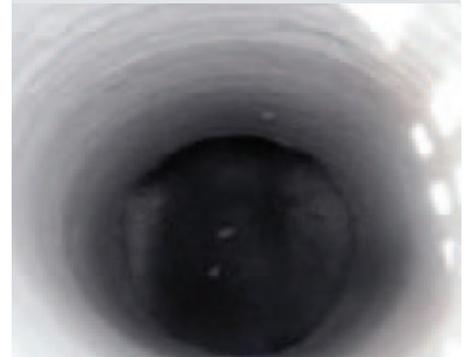
Completed manhole ready for service after eight hours.

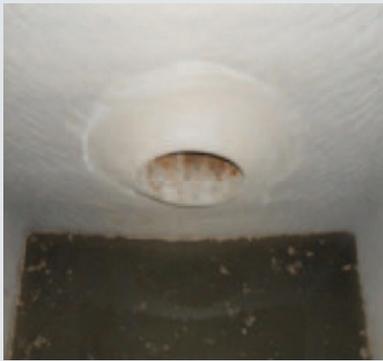
Manhole renewed with GeoSpray geopolymer.

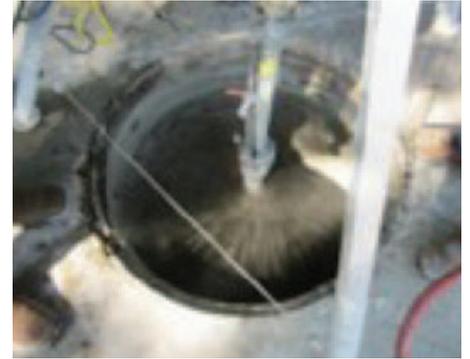
Centrifugal spraying of GeoSpray geopolymer.

The GeoSpray mortar was applied using a 5000 rpm rotary spinner. Although a one-inch thick application would provide a fully structural repair, the client chose a 1.5-inch thick lining to extend the life of the manholes.

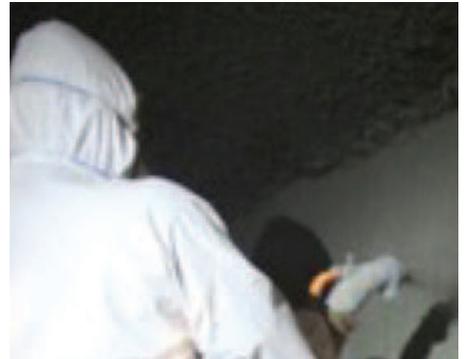
Hand spraying of GeoSpray mortar in catch basin.

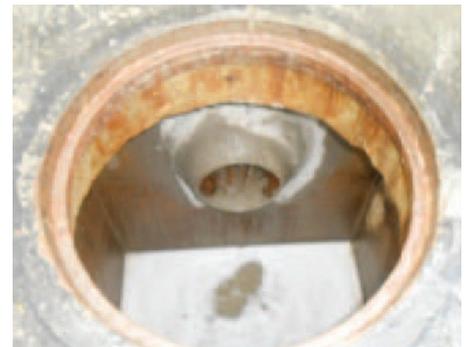
A southeastern US oil refinery decided to evaluate the condition of its process sewer manholes at one of its refinery sites. Refinery officials discovered the leaks while conducting a routine five year inspection of the process sewer line. Inspection results revealed that many of the manholes and catch basins had begun to leach where the trunk lines entered these structures.

After conducting an initial assessment of the most critical areas, it was determined the primary source of the leaks were coming from poorly sealed annular space around the pipes where they penetrated into the manholes. Although not all the manholes appeared to be leaking, the owner proactively chose to have all of them thoroughly inspected and repaired as necessary.

One of several hundred leaching and deteriorated manholes.

All manholes were washed and several required an acid bath to remove chemical build-up. All voids and excessive annular space was filled with a hydraulic cement or non-cementitious grout to stop leaks and infiltration.
