PROJECT OVERVIEW

Location: Balkhash, Kazakhstan

Application: Inlet Pipe Rehabilitation

Client: Kazakhmys Energy

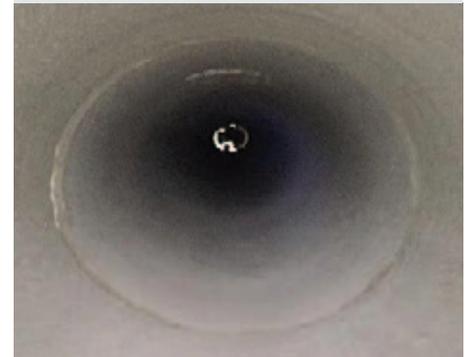
Final form of the pipe after rehabilitation.

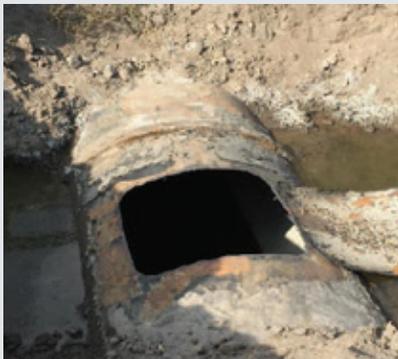
Due to the lack of access points throughout the pipe, the team had to create entrances.

The first step in the process was to determine how to access the pipe since there were few existing openings. The team selected eight points along the length of the pipe to excavate and then cut into in order to create an access point. The next step in the process was to clean the pipe with a high-pressure water cleaning system so that the pipe would be ready for repair.

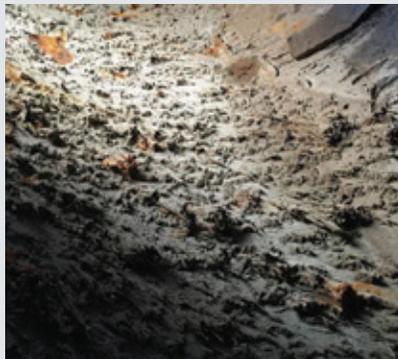
The existing input pipe system was in poor condition. After further inspection, it was discovered that the damaged pipe consisted of: 307 m of 2400 mm pipes, 97 m of 1200-2100 mm pipe with S-curves, and 218 m of 1000-1200 mm pipe. The pipe also showed heavy deposits of salts and metals throughout the system. Due to the risk involved and how much the repairs would cost, the client decided that standard CIPP would not be the ideal solution. Due to the cost effectiveness and flexibility of the GeoSpray technology, it was determined that GeoSpray geopolymer would provide the best results within the limited timeframe.

Over time, the pipe had corroded and had acquired heavy deposits of salts and metals.

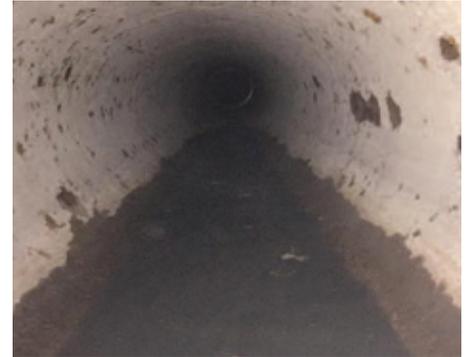
Condition of the pipe after the team had cleaned the interior.

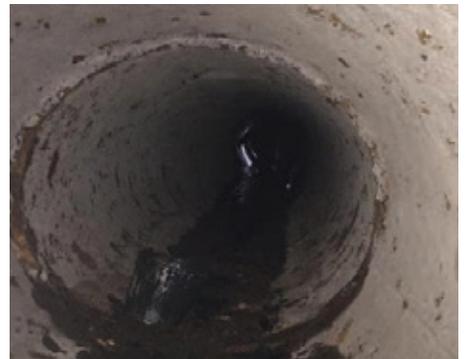
The pipe is now prepped and ready for GeoSpray mortar installation.

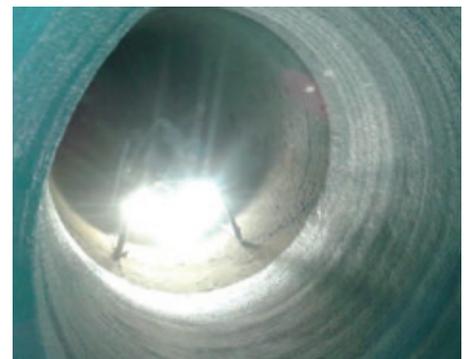
Pipe after first layer of GeoSpray mortar had been applied.

Once the pipe was cleaned, the first layer of GeoSpray mortar was applied via a mechanical sled spraying system. GeoSpray mortar was applied until the desired thickness of 25 to 38 mm had been reached. The pipe was sprayed in 11 sections all less than about 120 m in length in 1-3 passes per section depending on the diameter and required thickness. Finally, as the sections were completed, the access hatches were rewelded and the opening was coated with a shotcrete-like application of the GeoSpray mortar.
