PROJECT OVERVIEW

Application: Penstock Rehabilitation

Client: City of Auburn

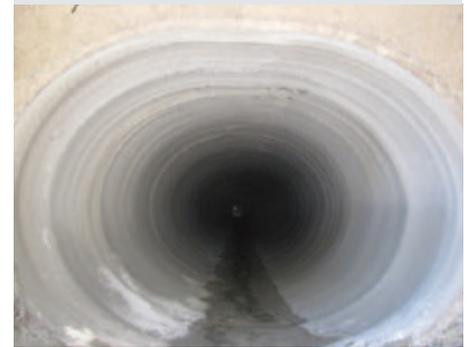
Completed penstock rehabilitation.

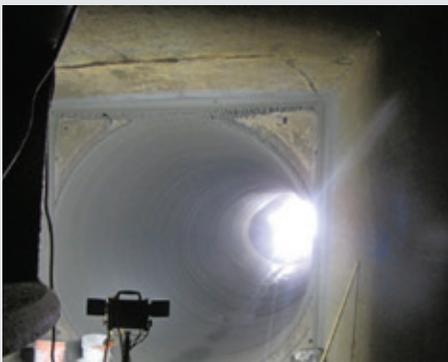
Lining after four complete passes.

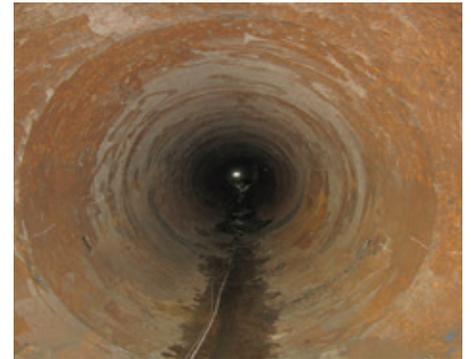
Welded steel pipe cleaned and prepared for geopolymer lining.

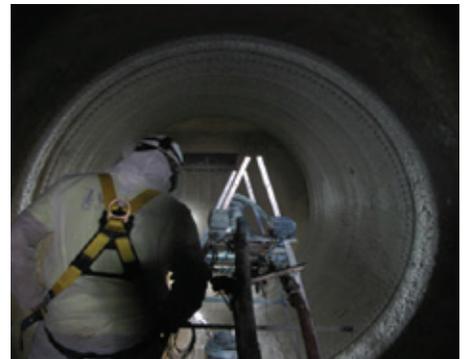
Application of geopolymer lining.

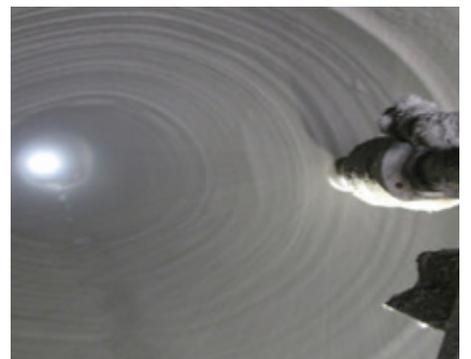
Close up of liner application.
