PROJECT OVERVIEW

Location: McAllen, TX

Application: Storm Sewer Rehabilitation

Client: Hidalgo County Drainage District

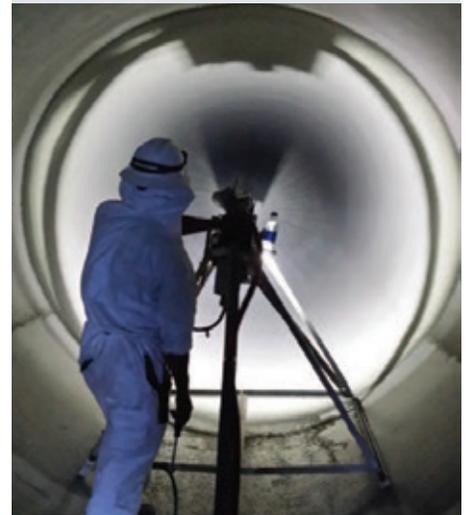
GeoSpray geopolymer being applied to corrugated metal pipe.

Once these issues were tackled, 150-to-300 foot sections were then sprayed with the final engineering designed thickness of 1.5 inches. The ability to apply a 1.5 inch-thick layer in a single spray pass saved the asset owner both time and money. During most days of operation, the contractor was able to apply between 20,000 and 40,000 pounds of GeoSpray geopolymers in a single run within the pipe, creating a truly monolithic structure.

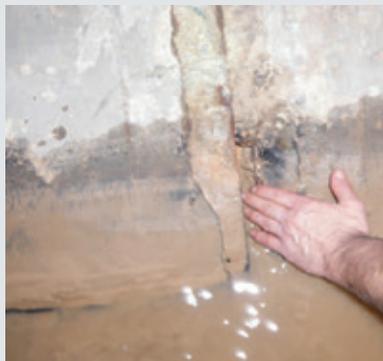
Previous repairs had damaged joints.

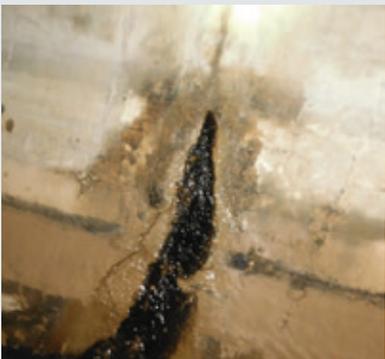
Active infiltration.

There were two side-by-side pipe sections, but only one was repaired at a time and all of the flow was diverted to the other section. Each pipe section was cleaned and inspected for joint failure, cracking and infiltration. Stopping water infiltration was the primary challenge of the project and required meticulous preparation. These issues were addressed with hand repairs to ensure that all the infiltration of water was stopped and a continuous surface for the application of GeoSpray geopolymers was created.

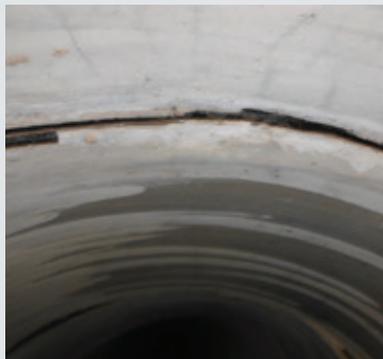
Joint separation.

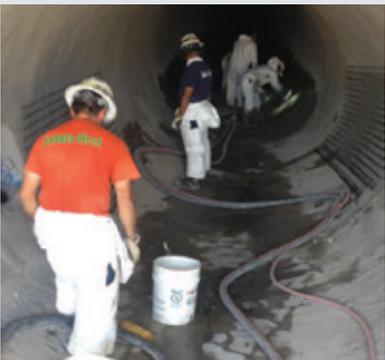
Pipe cleaning process.

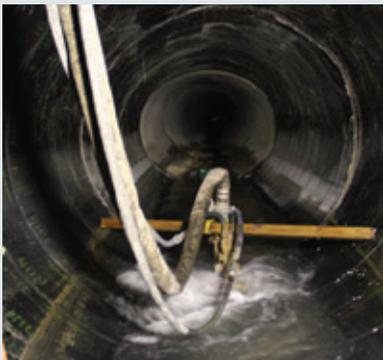
Pressure washing the pipe.

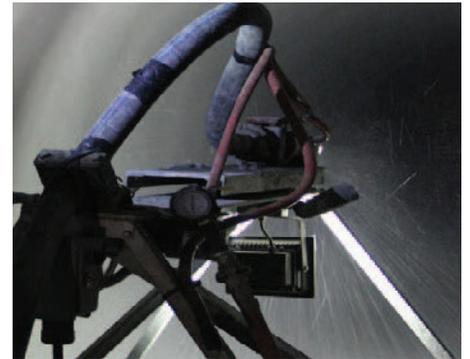
Centrifugal casting of liner.

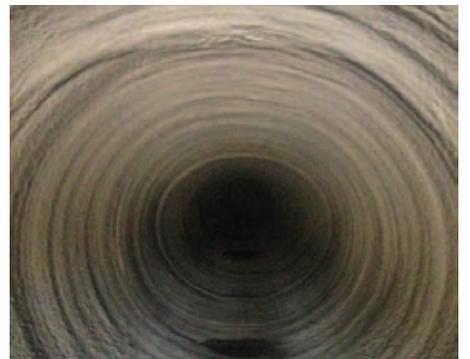
Final geopolymer pipe.

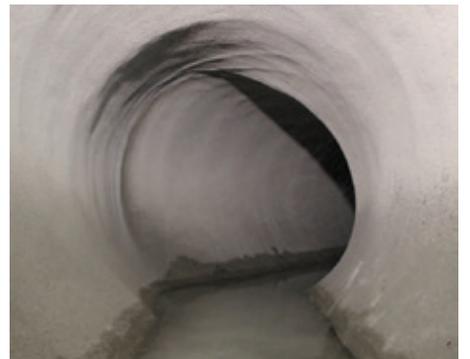
Monolithic transition around 45-degree bend.
