RENEWWRAP®

CASE STUDY:

Greenville, SC Column and Cap Repair

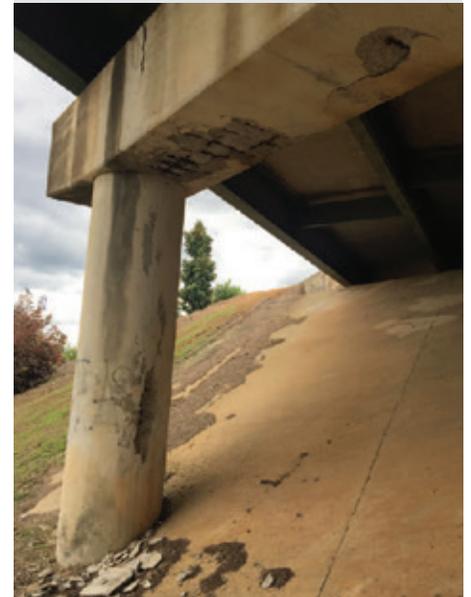
The SCDOT found corrosion-related deterioration of the pier caps and columns supporting the Butler Road bridge over I-385 in Greenville, SC, during a routine inspection. The corrosion was caught early enough and was limited to only one column and a couple of locations on the pier cap to be repaired by the SCDOT maintenance crews. To prevent further deterioration, the SCDOT determined it was necessary to repair the damage, restore any loss of strength and protect the pier from further deterioration. A repair that could be made quickly and with as little disruption to the traveling public was important.

Column and pier cap prior to repair.

Engineers visited the job site with the SCDOT to assess the scope of the problem and understand the objectives of the SCDOT. After the site visit, MIS recommended using GeoStrong™ geopolymer repair mortar to make the vertical and overhead spall repairs on the pier cap, followed by the application of a single layer of RenewWrap FRP strengthening system to restore any loss strength and to protect the pier cap from further deterioration.

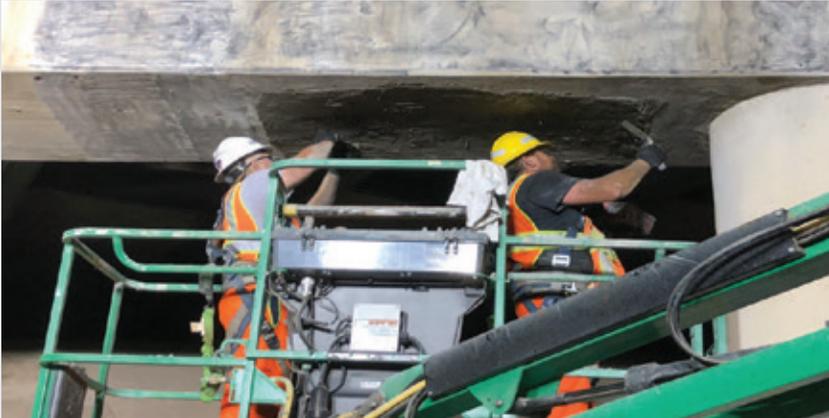
Application of GeoStrong repair mortar.

The work was completed by the SCDOT maintenance crews in the evenings to minimize lane closures on I-385. Standard concrete repair methods were used by the SCDOT to make the repairs. Once the loose concrete was removed and the corroded rebar was cleaned, the GeoStrong geopolymer repair mortar was placed by hand to fill the spalled sections. Unfortunately, heavy rains in South Carolina forced the crew to shut down before the patching could be completed. When they returned two weeks later, they could patch directly over the cured GeoStrong material with confidence knowing that cold joints are not a concern with MIS's innovative geopolymer material.

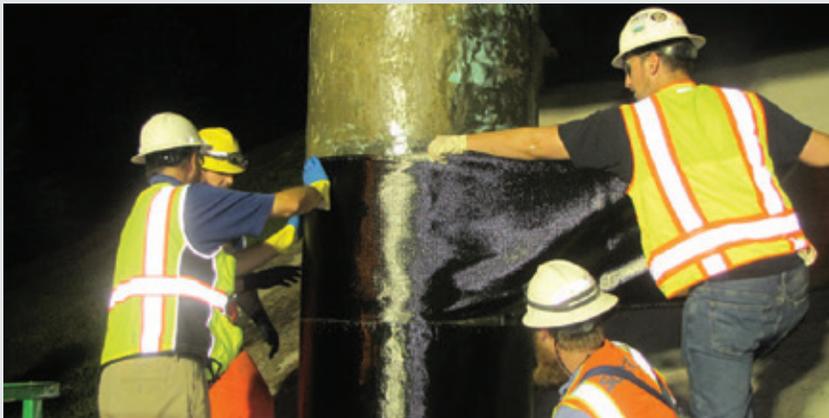
SCDOT maintenance crew wrapping pier cap with RenewWrap FRP system.

When the GeoStrong mortar was applied and cured, MIS engineers instructed the maintenance crew on how to apply RenewWrap FRP system to the pier cap and column. The carbon fibers were aligned in the same direction as the corroded reinforcing steel to provide additional strength and protection to the damaged areas. The following night, the SCDOT coated the RenewWrap with a Sherwin-Williams epoxy paint to match the rest of the pier. To the traveling public, the pier looks like a brand-new structure.

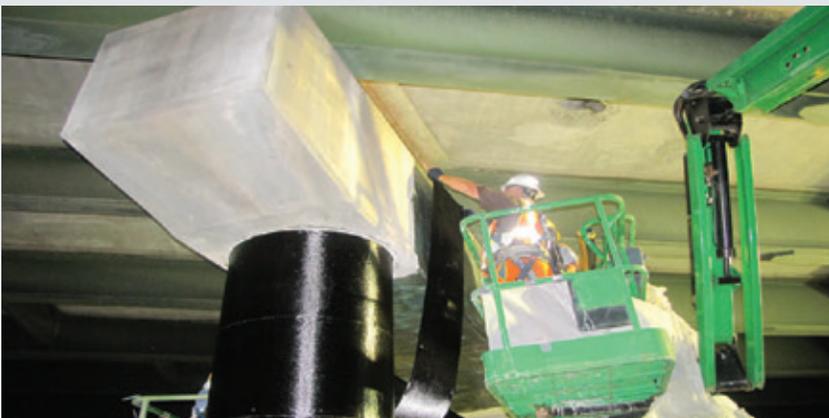
Application of RenewWrap FRP around column for confinement.

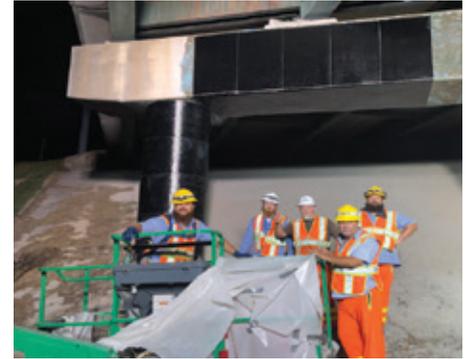
Completed repairs prior to coating.

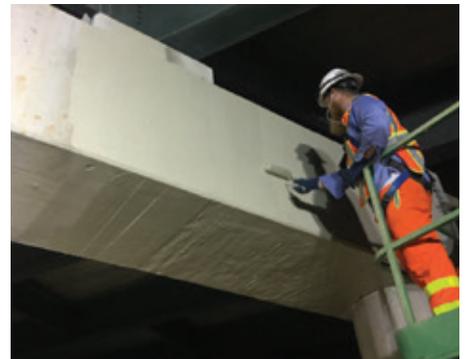
Painting RenewWrap FRP system with epoxy coating.

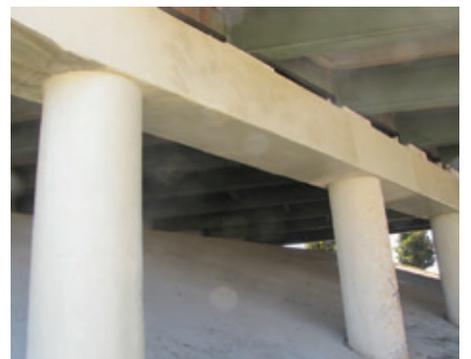
Completed column and pier cap.
