# WATER TANK STRENGTHENING GEAR ISLAND WTP

Location: Wellington, NZ

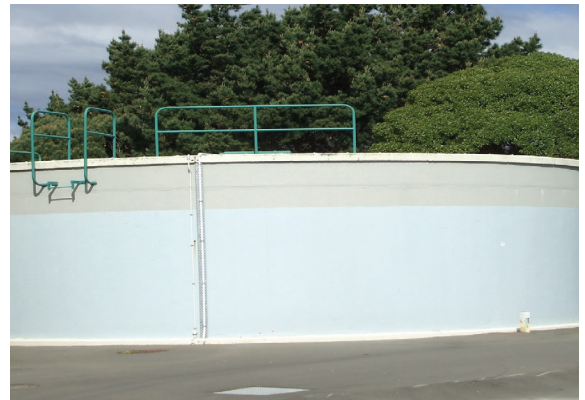
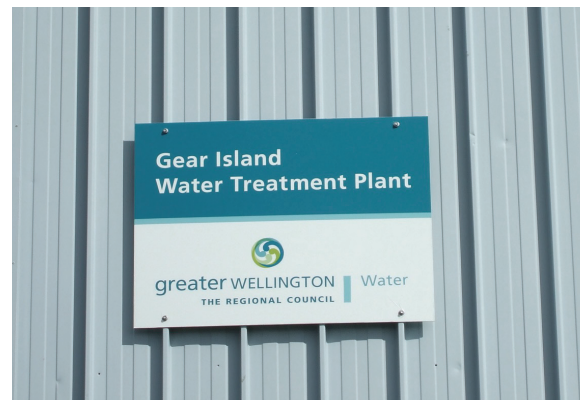
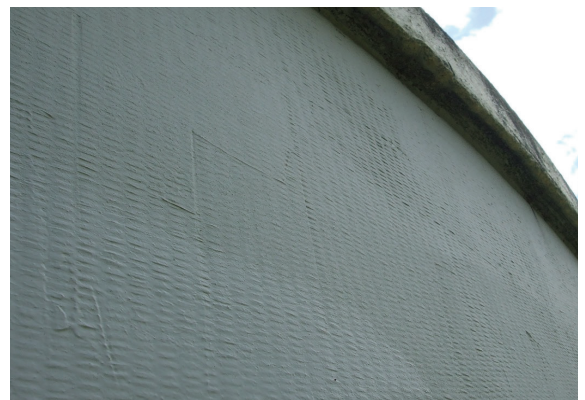
Under the effects of seismic activity, the top of the tank was capable of separating from the tank walls with significant differential deflection, requiring urgent remedial attention.

The solution called for a two pronged approach; Starter bars were drilled through the top down into the walls and grouted.

Five layers of Tyfo SEH® 51A was applied in a band around the top of the tank walls to provide confinement and prevent flexing. The Tyfo® was painted with Tyfo® A Acrylic Finish Coat to protect the Fibrwrap from UV and blend the retrofit area to the rest of the tank.
