SJRA - LAKE HOUSTON PUMP STATION #2

Effluent pipe lines rehabilitation

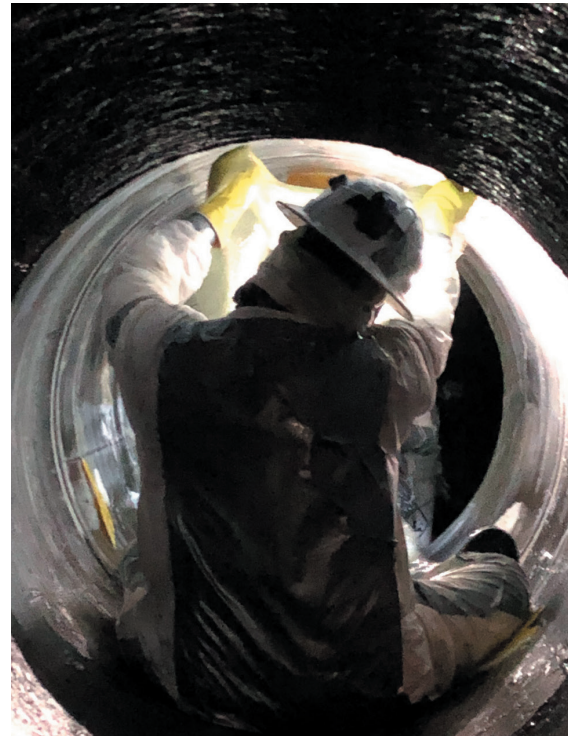
Lake Houston pump station intake piping

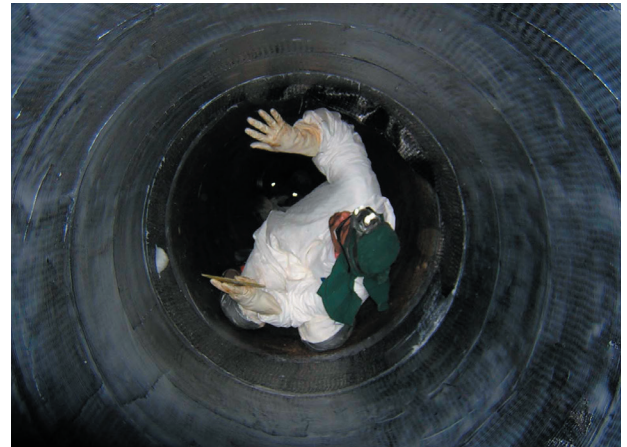
30-inch diameter pipe application

The scope of work included strengthening segments on each of the three effluent pipe lines, including conducting the required surface preparation, end detailing, fiber installation, finish coat installation and conducting all the required quality control measures. The pipe length of each repaired section was 13, 18 and 27 lineal feet.

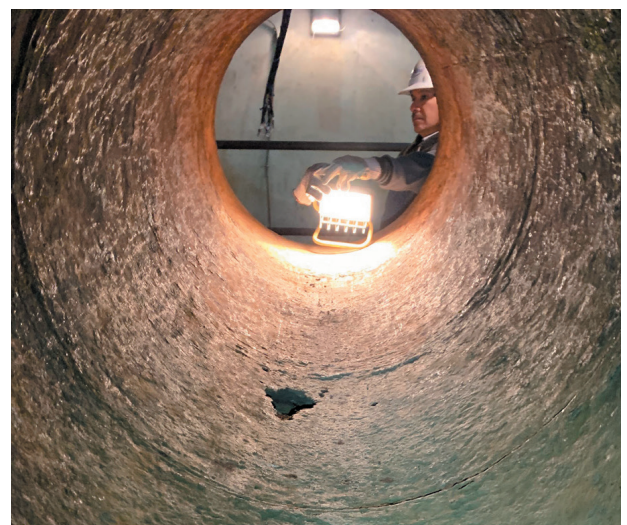
SJRA - before, post surface prep

1. Removal of cement mortar liner.
2. Prepare the exposed steel substrate by sandblasting to SSPC No. 10, to near white metal..
3. Conducted through wall hole repairs by filling voids with owner approved materials and with a proprietary watertight detail, which prevents groundwater infiltrating the pipe during construction activities.
