# DiamondWrap® Delivers Temporary Repair for Internal Corrosion

Venezuela

### PIPE DETAILS

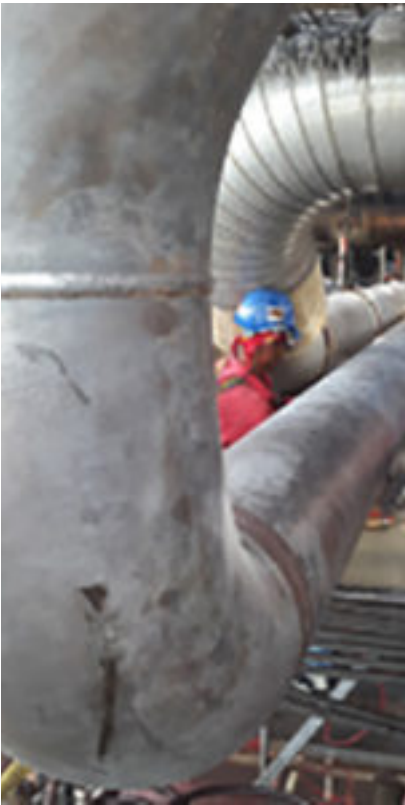
*DiamondWrap Internal Corrosion Repair*

When the repair kits arrived on site, a team of 8 Clock Spring trained and certified installers began work on the line. The first step was to mechanically prepare the line using a Bristle Blaster. With the line properly prepared, installers began layering the carbon fiber over the repair areas according to the repair plan, wrapping the line, including the T's, bends, and elbows.

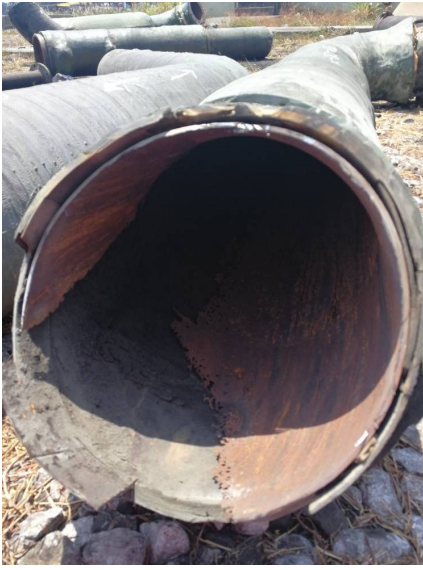
*Repair Forms Long Lasting  
New Pipe*

The installation was carried out with the line temperature at 76.7° C (170° F). The high temperature would have negatively affected most composite cures, but the DiamondWrap® HT701™ system is designed for high-temperature applications and allowed the cure to be managed properly.

It took a team of 8 installers a month to completely wrap the pipe. During the installation process, no heavy equipment was introduced, and no hot work was required, allowing the line to remain in operation with no disruption in production. Despite the extensive corrosion and difficult installation conditions, the team completed the job without incident and returned the line to safe service.
