# RENEWWRAP®

## Systems Repair & Strengthen Hospital Parking Facility

Our Lady of Bellefonte  
Hospital, Ashland, KY

**Application:** Strengthening of post-tensioned concrete slabs

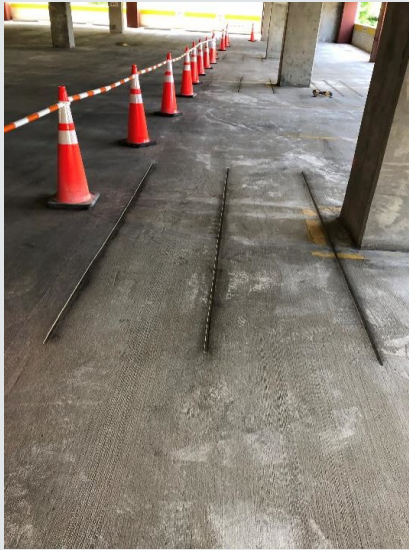
1. Saw cuts were made along columns in preparation for the NSM CFRP bars.

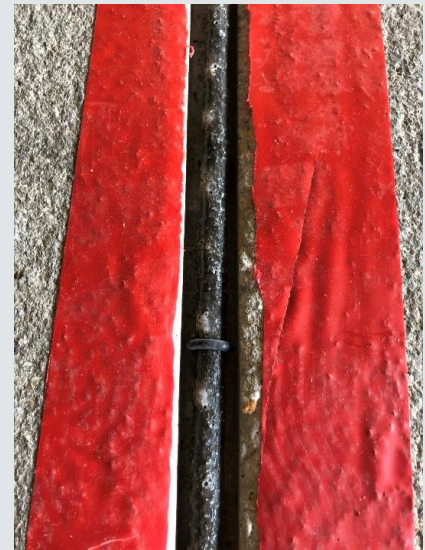
4. O rings applied to 3/8" NSM CFRP bars to provide proper placement into the cut.

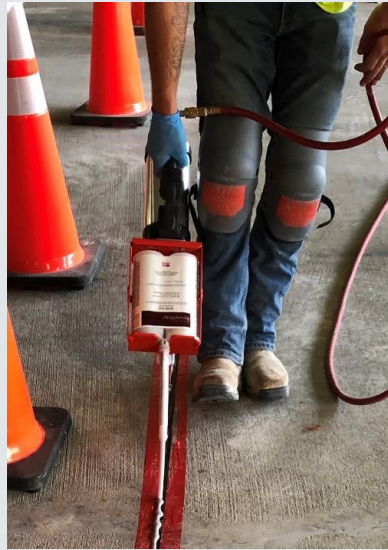
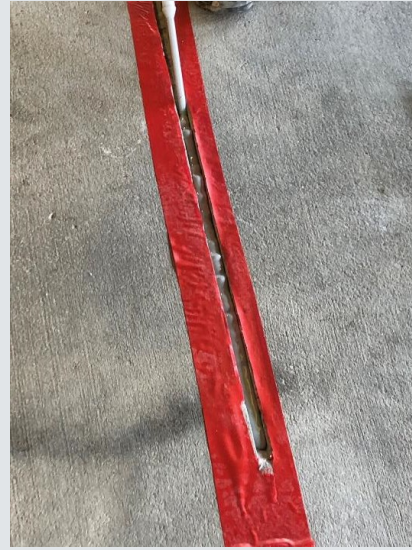
5. RenewWrap NSM Gel was placed into the cut prior to CFRP bar placement.

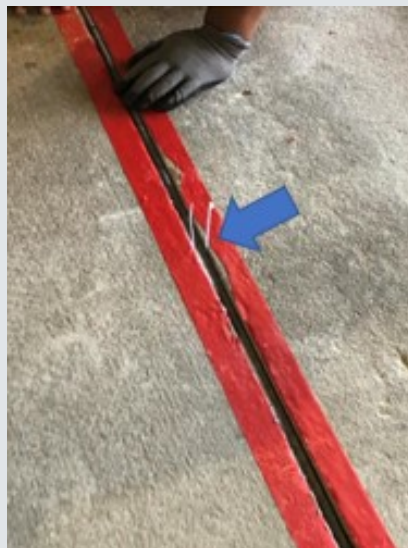
6. RenewWrap NSM CFRP #3 bar placed into cut. Nails were used to stabilize the rod during initial set of NSM gel. This assured 100% encapsulation of the rod with the gel.

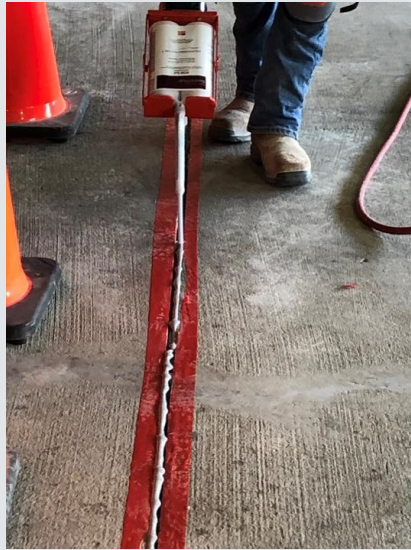
7. RenewWrap NSM Gel applied over inserted rod and tooled flush with substrate.

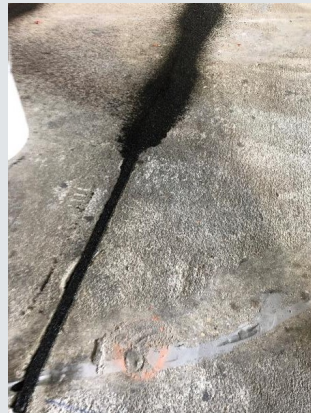
8. Aggregate was broadcast onto wet gel, and then excess was removed after cure of sealant. This step was an option selected to enhance adhesion of traffic coating to follow.

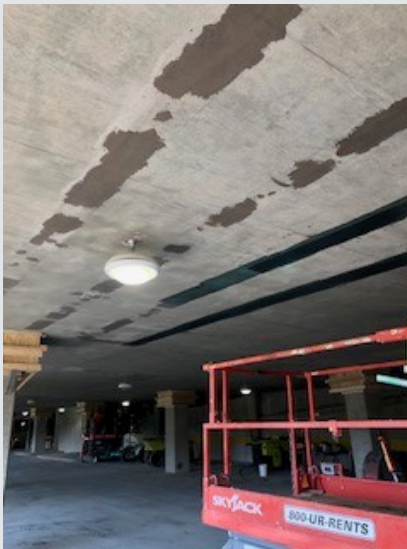
1. Strengthening of parking deck partially completed.

The RenewWrap ESR CFRP system was used to strengthen the slab from the bottom. The fast and clean installation required minimal preparation and was completed using CF600 EZ-Slit fabric.

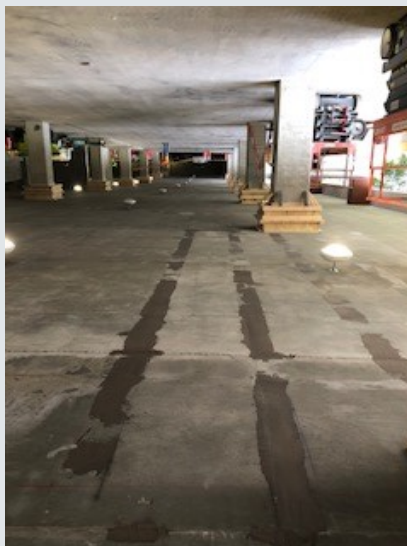
4. The slab preparation is completed prior to the application of the RenewWrap CFRP system.
