# GEOSPRAY®

### CASE STUDY:

## City of Memphis Twin Concrete Box Culvert

**Application:** Twin Concrete Box Culvert (8.5' x 8')

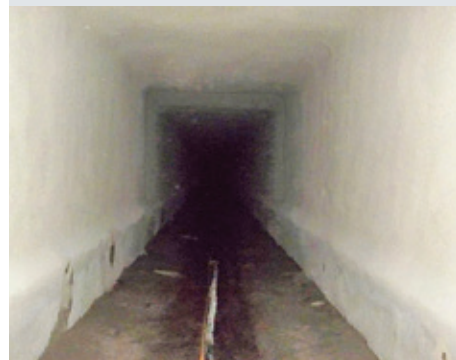
Final structurally enhanced box culvert back in service

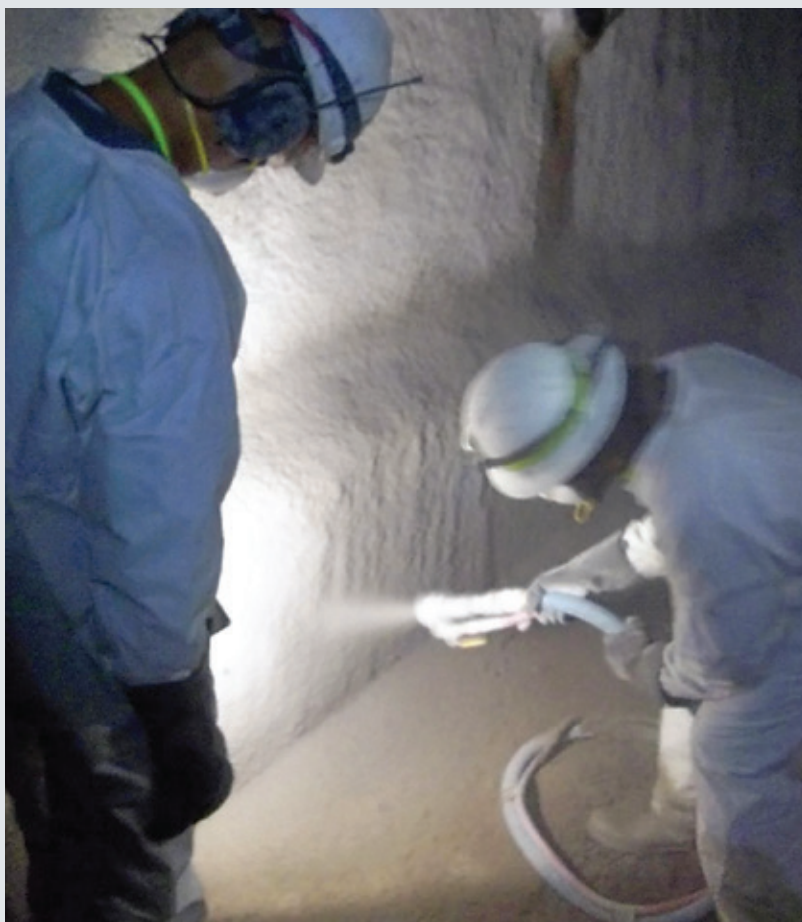
Hand spray application of GeoSpray mortar lining

Once the design was approved by the city and the engineer, work began on the culvert in earnest in early November 2017, after delays in the summer of 2017 due to excessive flooding in the area that made dewatering the culvert impossible. To begin repairing the culvert, all flow had to be diverted into a single side of the culvert. The culvert was pressure washed to remove debris and loosely bonded concrete, and any exposed steel was cleaned and coated. All active infiltration was stopped using hydrophobic grouts. Finally, a 1.5" inch geopolymer coating was applied to the structure starting at the bottom of the vertical walls, moving overhead and finishing the bottom of the culvert.

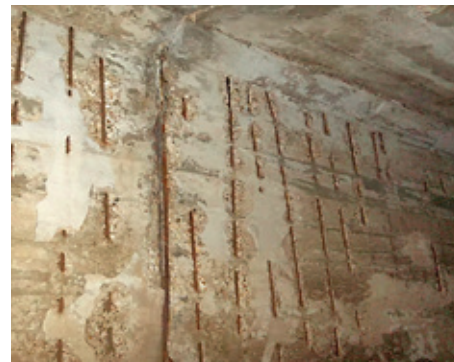
A full inspection of the system concluded that the box culverts had severe corrosion, spalling and cracking that were the source of infiltration and inflow, as well as minor corrosion to some of the existing steel structure, but in general the steel cage of the existing box was still structurally sound. This is typical of most concrete storm water culverts where the true deterioration has affected some level of the steel but the actual box is still structurally sound.

Spalling and corroded rebar in the box culvert

The project was advertised in November of 2016 with the option of structural enhancement of the twin box culverts and GeoSpray® geopolymer mortar was specified as the approved product. Inland Pipe Rehabilitation, LLC (IPR) was awarded the project in early 2017. The design of the box culvert rehabilitation included applying a minimum of 1.5" of geopolymer mortar to recover and protect the steel structure as well as fill in voids, cracks and other defects that were allowing water infiltration into the culvert from the surrounding soil.

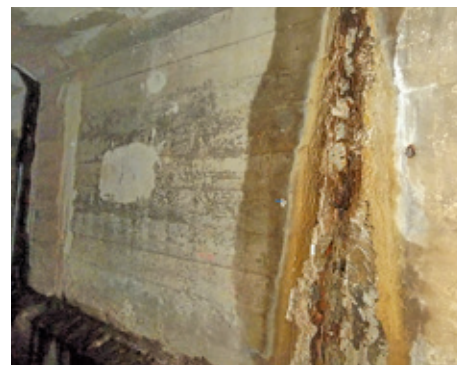
Cracks with active infiltration

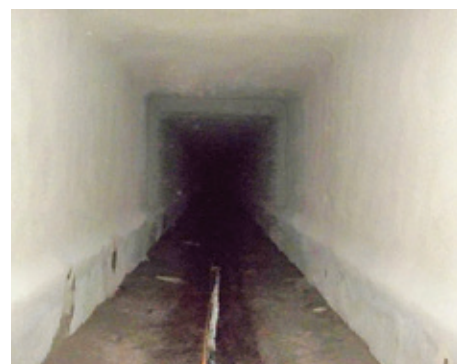
Completed GeoSpray Geopolymer lining
