# VENOCO CARPINTERIA PIER REPAIR AND RETROFIT OF CORRODED BEAMS

Location: Carpinteria, CA

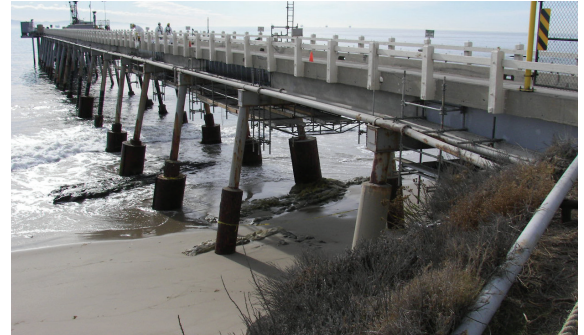
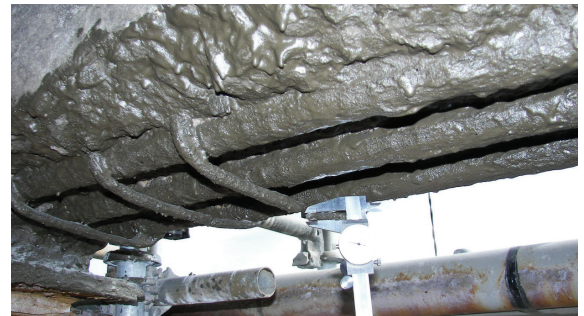
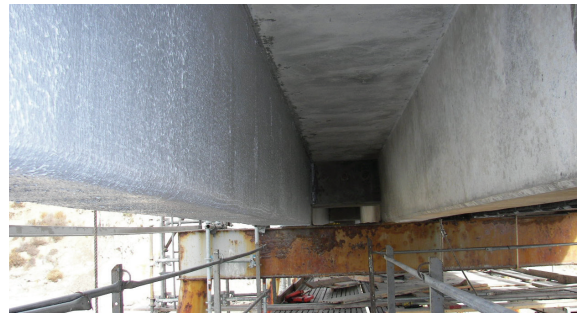
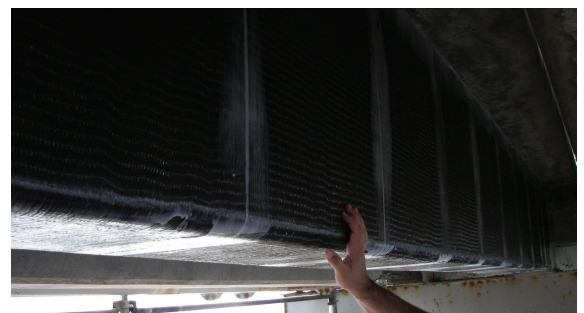
The Venoco Inc. service pier in Carpinteria California showed severe signs of deterioration on the reinforced concrete beams running parallel to the structures primary axis. Steel corrosion produced large spalled concrete areas and this alerted the client to retain FCI to perform a design-build structural repair.

A suspended platform was constructed to provide working space for the crew, and at the same time, protect the beams from the ocean surge. A process of discovery was initiated to remove unsound concrete. After treatment with Tyfo® CIS, a corrosive inhibitor system, the exposed steel and surrounding concrete was sandblasted. Polymer-modified concrete was then applied to reform members to their original shape by forming and pouring. After the client and FCI quantified the steel section loss, the Tyfo® SCH uni-directional carbon Systems was designed and installed to supplement the transverse steel lost due to corrosion. The composite system also served as a superb coating which prevents contaminants from reaching the reinforced concrete section, thereby preventing corrosion. The Tyfo® Systems restored the structural capacity back to original strength and was completed in an environmentally-sensitive area where seals and sea lions make their natural habitat.
