# GEOSPRAY®

Geopolymer Mortar

## CASE STUDY: Pipe Rehabilitation, City of Columbia

**Application:** Brick and granite water canal

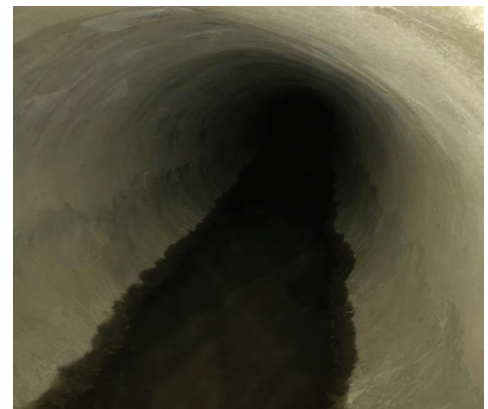
In late summer of 2012, the City of Columbia under Pizzagalli Construction Company, the general contractor for the wastewater treatment plant rehabilitation, sub-contracted a 440 linear ft section of 72-inch x 60-inch concrete and stone tunnel to IPR. It was the City's first project with spray-applied geopolymers and offered the City a long-term look at the technology. Prior to specifying the remainder of the storm water conveyance tunnel running under the WTP, the City conducted a complete inspection of the pilot project and found the structure to be unchanged since its installation five years prior. The image to the right shows the inspection conducted in 2018.

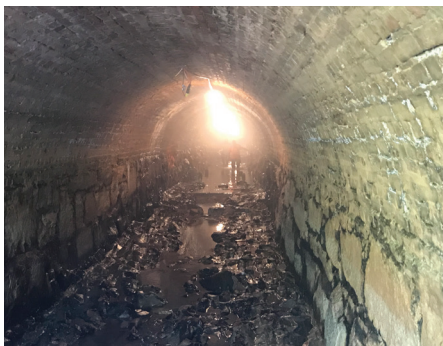
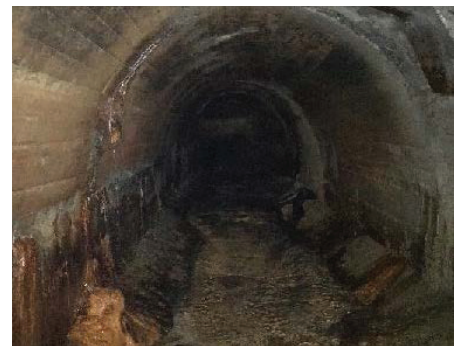
The project was awarded to IPR with work starting in June 2019. The contractor chose GeoSpray® geopolymer mortar produced by GeoTree Solutions. The full project consisted of lining 120 linear ft of 54-inch x 72-inch arched brick pipe and 455 linear ft of 96-inch x 96-inch arched brick pipe. Much of the existing material had granite blocks in the lower section of the pipe and brick in the arch. Many sections had severe deterioration.

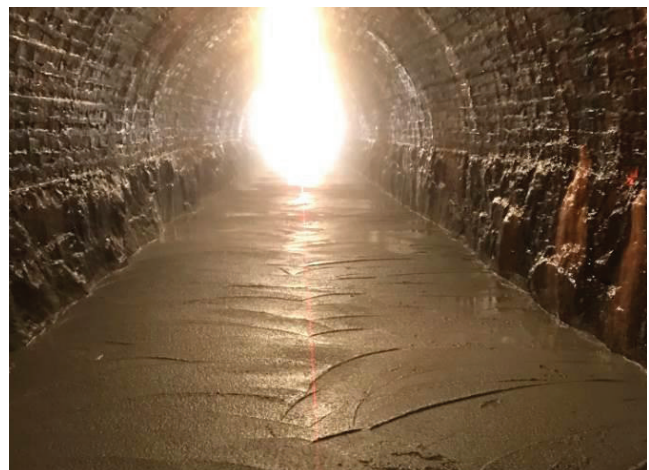
The project was divided into three sections. The first was approximately 455 linear ft and the other were each approximately 60 linear ft. The first step of the application was to pour a 2 ft thick floor to the structure with a low strength (3000 psi) compressive strength flowable fill concrete. This was necessary to smooth and level the full section of the tunnel floor, allowing improved hydraulics and facilitating hand-sprayed lining operations. Pouring the floor for the whole project length took two days. Preparation and grouting of each of the sections took approximately one to two days per segment.

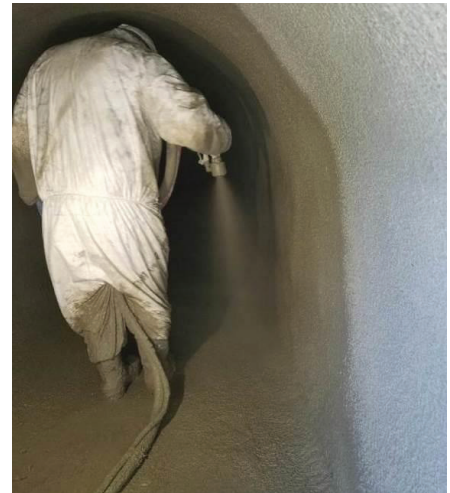
Once the floor was poured the conveyance tunnel was prepared to receive the lining. The contractor hand-sprayed the geopolymer mortar to create the required design thickness. The material was pumped up to 500 feet after being mixed on the surface, and the thickness was built up over several applications. Typically, for hand-spray applications, material will first be applied on the tunnel wall near the invert, then on the vertical wall and then on the crown. The final application being applied to the invert. One of the key advantages of this specific geopolymer mortar is that it bonds chemically to itself and doesn't allow for the formation of a cold-joint which may occur on multi-layer applications of other cementitious materials. The 455 linear ft section took eight days to spray and the other two sections took less than two days each.

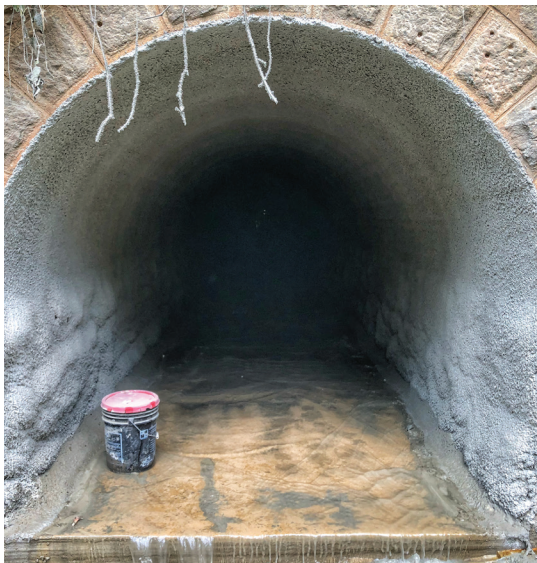
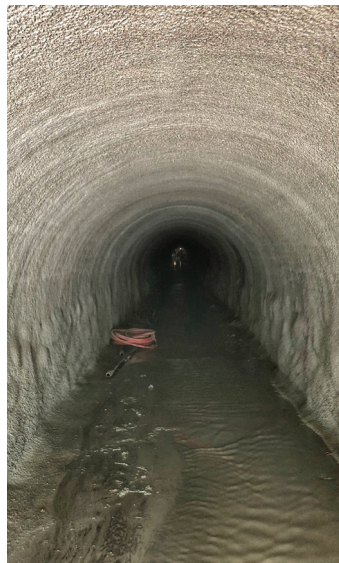
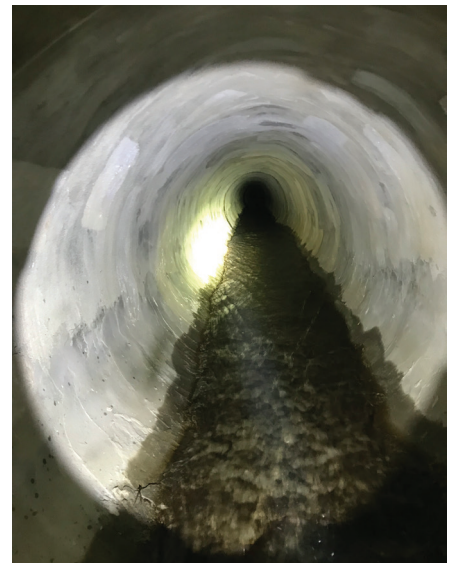
The full project construction of the conveyance tunnel rehabilitation was completed in under three weeks. After the liner was completed a pressure grouting technic was used to grout behind the lining and stabilize the soil, this required cutting ports into the lining that were then repaired with the same geopolymer after the grouting was complete.
