# STRUCTURAL STRENGTHENING OF ELEVATED SLAB DUE TO DAMAGED REINFORCING STEEL

Concrete slab strengthening.

## PROJECT PROFILE: STRUCTURAL STRENGTHENING TYFO® SYSTEM

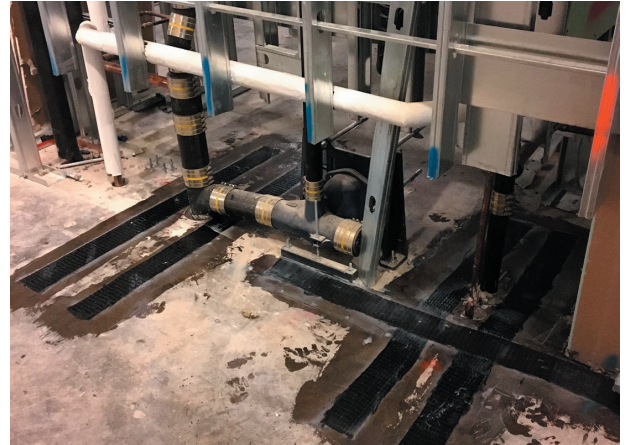
Strengthening in both transverse and longitudinal directions

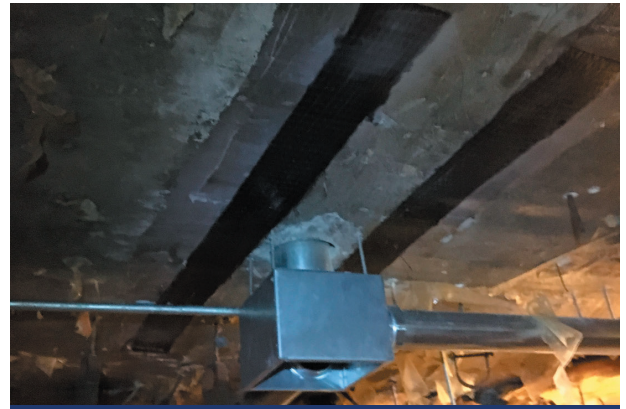
Underside of the slab positive flexural strengthening
