COMPOSITE SOLUTIONS IMPROVE MIDSTREAM ASSET INTEGRITY

BY ANDREW PATRICK AND TIM MALLY

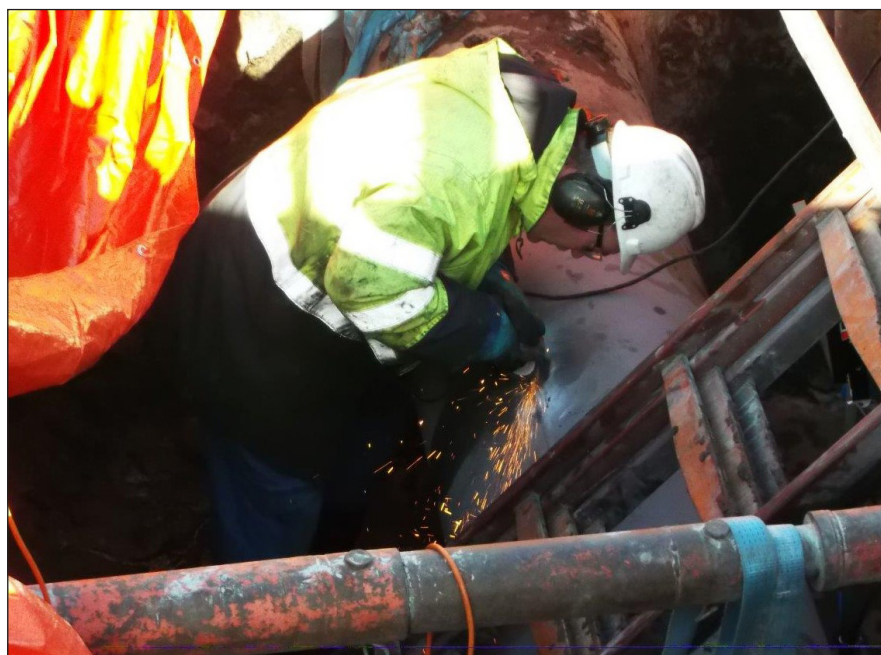
Technicians remove the crack in the seam weld with a grinder to prepare the surface of a carbon steel crude oil pipeline for a composite repair. Photos courtesy of CSNRI

In another pipeline repair, an owner of a 610-mm (24-inch) carbon steel X52 crude oil pipeline in the Netherlands needed to address a dent and a related crack in a seam weld. One of the safety objectives was to avoid welding, so a cut and replace solution was immediately ruled out.

The pipeline operator took the line out of service – but did not evacuate it – while a team of two technicians removed the crack in the seam weld with a grinder. When the installers had ground the pipe sufficiently to remove the crack and filled the dent using the filler kits, they repaired the line using the composite sleeves.

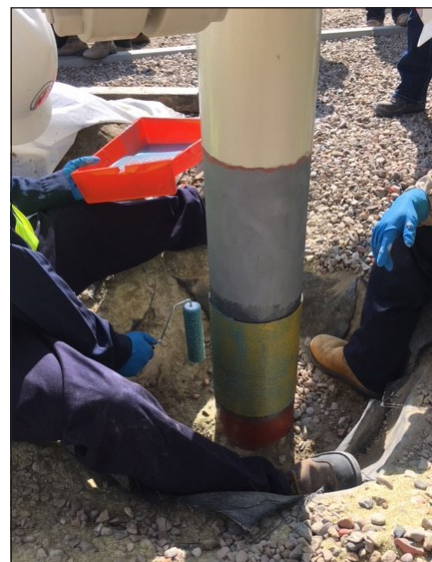
Installers secure Snap Wrap to strengthen a pipe and protect it at the air/soil interface.

The range of requirements necessitated the use of multiple products, including Snap Wrap, Contour and Pipe Support.

Once the repairs were designed, a team of 25 technicians removed soil overburden around the pipeline and began the process of abrasive blasting the first of 1,118 locations that eventually would be covered by the Snap Wrap, Pipe Support and Contour WA products. With the surface prepared, the team could apply the necessary adhesive and install the composite solutions.

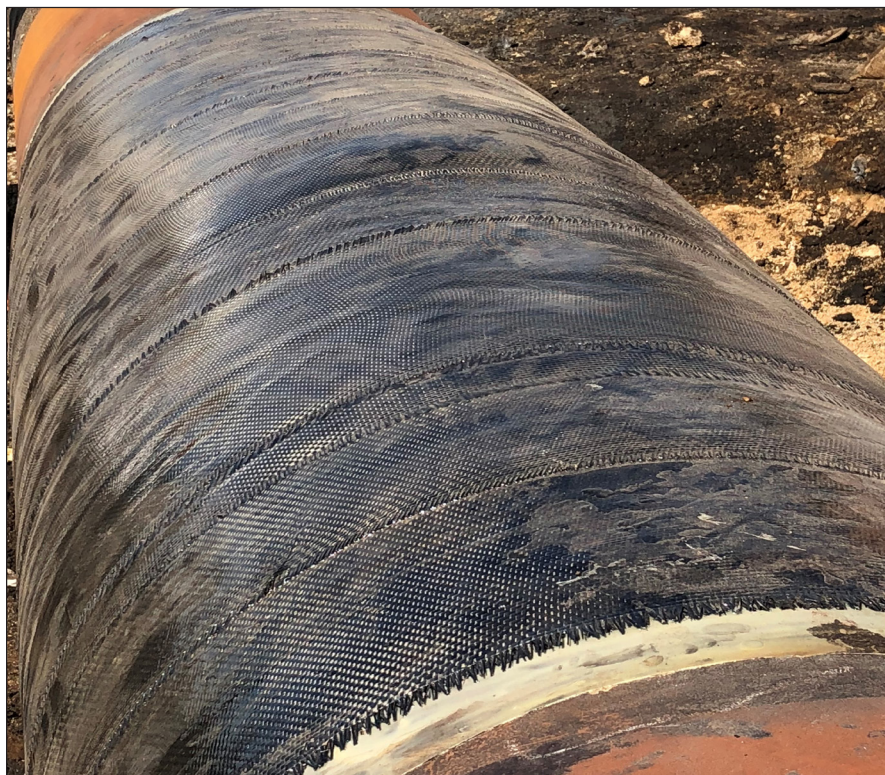
A line damaged in an explosion is wrapped with 26 layers of DiamondWrap and restored to safe service.

Composite technology also is often applied in emergency conditions, as in the case of a refinery in Bahrain that experienced line damage from an explosion that created a 3.5 by 4.5-inch (343 mm by 114 mm) hole in a 28-inch (711-mm) carbon steel pipeline.

DiamondWrap was applied to arrest the leak and restore the line. As soon as the composite system was designed, a team of 12 trained technicians was dispatched to the refinery. Crude flow through the line was stopped while the team plugged the hole and began preparing the surface of the pipe for the composite repair, which was carried out with about 50 percent of the crude oil remaining in the line.

Technicians installed DiamondWrap over a 9.8-ft (3-meter) length of pipe. Working continuously, the team completed the repair in 16 hours, working through the night to finish the installation as quickly as possible to restore the line integrity so refinery operations could recommence.
