Composites Take on Air-to-Soil Interface Corrosion on Gas

California

Pipe Details

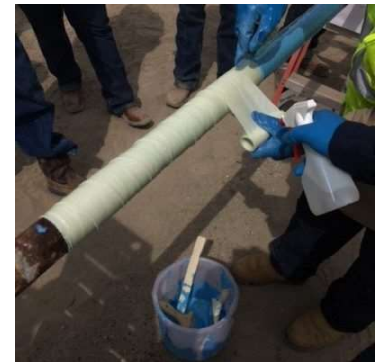
CSNRI trained and certified technician apply Contour WA™ to a prepared line.

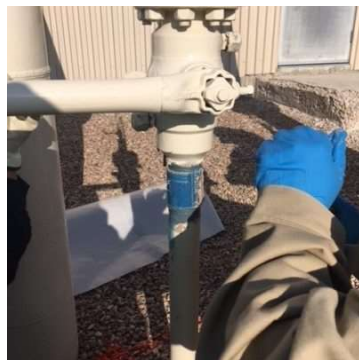
Pipe supports are installed to limit the effects of corrosion and the environment for the gas transmission lines.

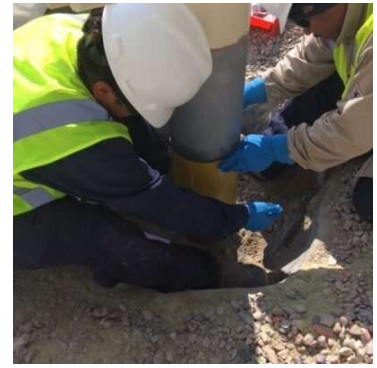
Installers secure Snap Wrap to strengthen the pipe and protect it at the air/soil interface.
