A Jack of All Trades

Myles Johnson, ClockSpring|NRI, USA, considers the various applications of composites for piping systems at risk of corrosion.

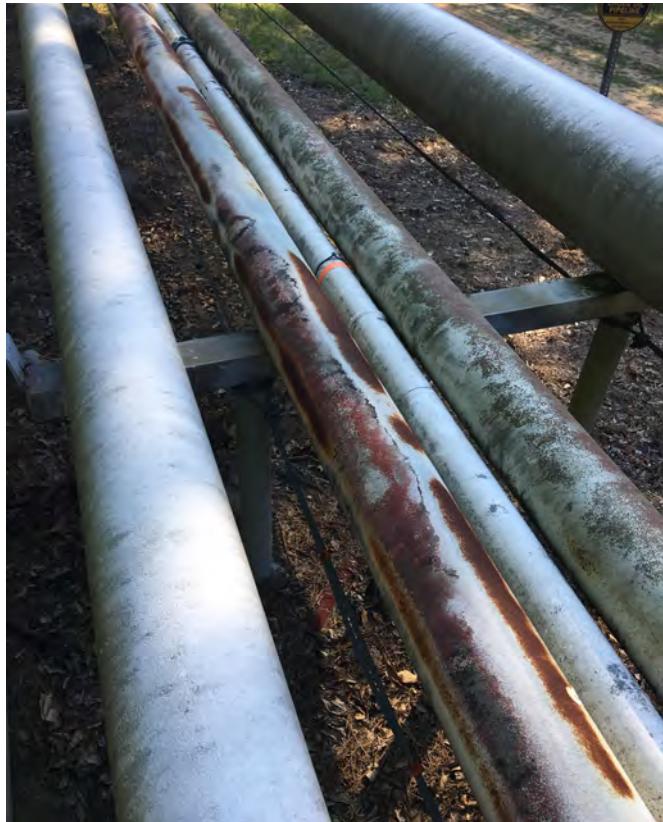
Figure 1. It is common for pipelines to experience abrasion and corrosion at support and hanger locations.

A 6 in. pipe was experiencing general external corrosion due to contact with a pipe support and a collar clamp (Figure 1). In addition to restoring lost strength, a composite wrap was utilised to prevent further metal-to-metal contact with the pipe support and minimise movement and corrosion in the collar clamp. To wrap over the collar clamp, the empty space around the bolts needed to be filled in to remove air-pockets and voids underneath the composite repair. To achieve this, a thixotropic, non-sagging filler paste was provided that had a consistency similar to peanut butter and is easy to apply in large volumes. After the filler paste was allowed to set, it was wrapped with a composite to provide structural reinforcement to the affected pipe and prevent further metal-to-metal contact (Figure 2). Although rigid fibreglass wear-pads can be used to prevent crevice corrosion, a field applied composite can be applied in unique situations where pre-formed solutions are neither practical nor convenient.

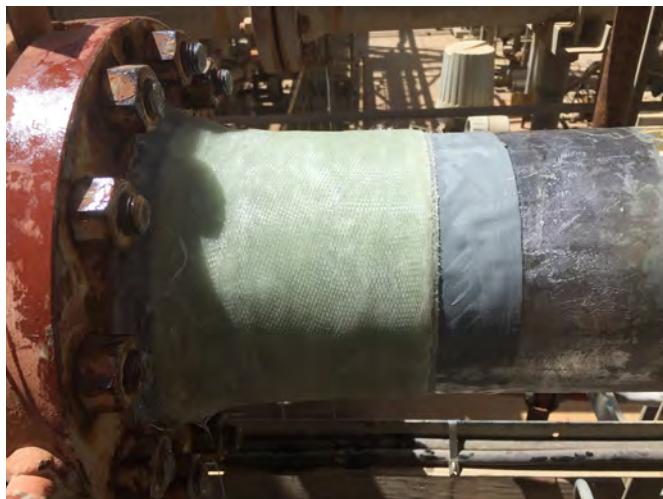
Figure 2. The composite system creates a sacrificial wear plate, preventing both crevice and galvanic corrosion, accommodating the weight of the pipe and preventing abrasion from pipe movement.

Another dangerous area for potential corrosion is any location where the pipe is in contact with something else. Composites built for energy absorption and stress redistribution can be ideal for impact protection and vibration dampening. Additionally, pipes resting on supports are susceptible to crevice corrosion due to axial movements and vibrations that will wear down the coating over time, resulting in metal-to-metal contact with the support. This results in the localised attack of metal at the support. One of ClockSpring|NRI's technologies, the Pipe Sock™ system, is designed to prevent this situation from occurring. The system consists of a pre-cured fibreglass wear pad and an elastomeric adhesive. In addition to having high adhesive properties, the elastomeric polymer demonstrates a greater toughness and flexibility, which allows it to survive conditions that would otherwise cause cracking and failures for similar epoxy-based wear pads. Some of the conditions that should be considered when dealing with crevice corrosion include thermal expansion, vibration, axial loads and types of pipe support.

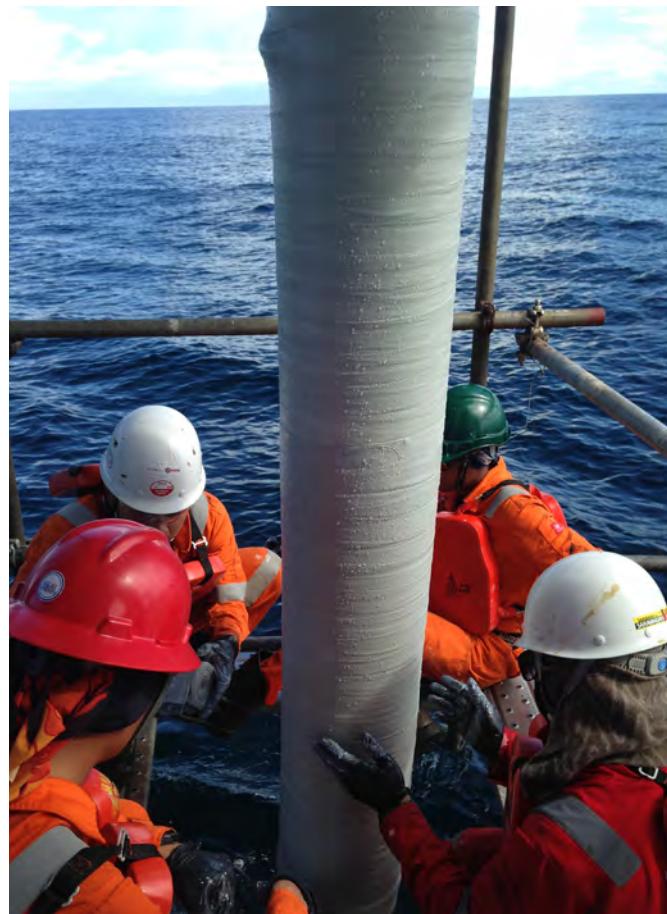
Figure 3. The polyurethane system within the A+ Wrap system utilises moisture to start the polymerisation reaction and can function in wet environments.

Another operational difficulty is repairing pipes located in splash zones or underwater. Most epoxies are hydrophilic, which means that they will not cure properly in the presence of high-moisture content. This is a significant problem for offshore facilities where many of the damaged pipes are in a splash zone or underwater. Instead, a hydrophobic epoxy should be used because its cure is not adversely affected by the presence of moisture, which allows it to be used in wet environments.
