Wrinkle Bend Repair in Canada

Pipe Details

- Liquids Pipeline Operator
- 10" pipe diameter
- 725 psi design pressure
- Crude oil pipeline
- Wrinkle Bend

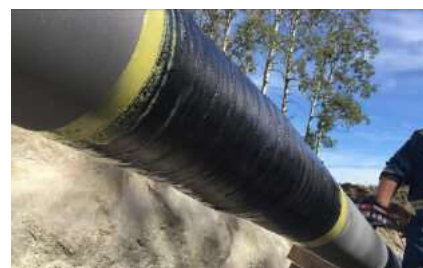
Completed repair

CSNRI had previously teamed with the specified contractor on previous Canadian DiamondWrap® repair opportunities, and the contractor already had several trained and certified installers. This partnership with the contractor saved the pipeline operator time and money as they did not have to call out two separate service companies to perform both the dig and the installation. The repair also did not require the high cost of welding labor. The high compressive modulus filler putty was installed to smooth any stress concentrations around the wrinkle bend as a material to transfer the load from the pipe to the carbon fiber repair system. The primer was installed next to increase the bond between the repair and the pipe. 6 layers of carbon fiber were installed over a 1 meter repair length to repair the wrinkle bend defect.

Two trained technicians were able to complete the installation within approximately two hours. No heavy equipment or hot work was required for the installation, and the line remained in operation during application. The repair was installed and cured within a half of a day, allowing the pipeline operator to quickly and efficiently move on to future digs. Below are photos of the completed repair and repair process.
