COMPOSITE REPAIR: STILL GOING STRONG

Matt Green and Tim Mally, CSNRI, USA, describe the testing of a 25 year old repair completed with composite repair sleeves, that left pipe sections even stronger than before.

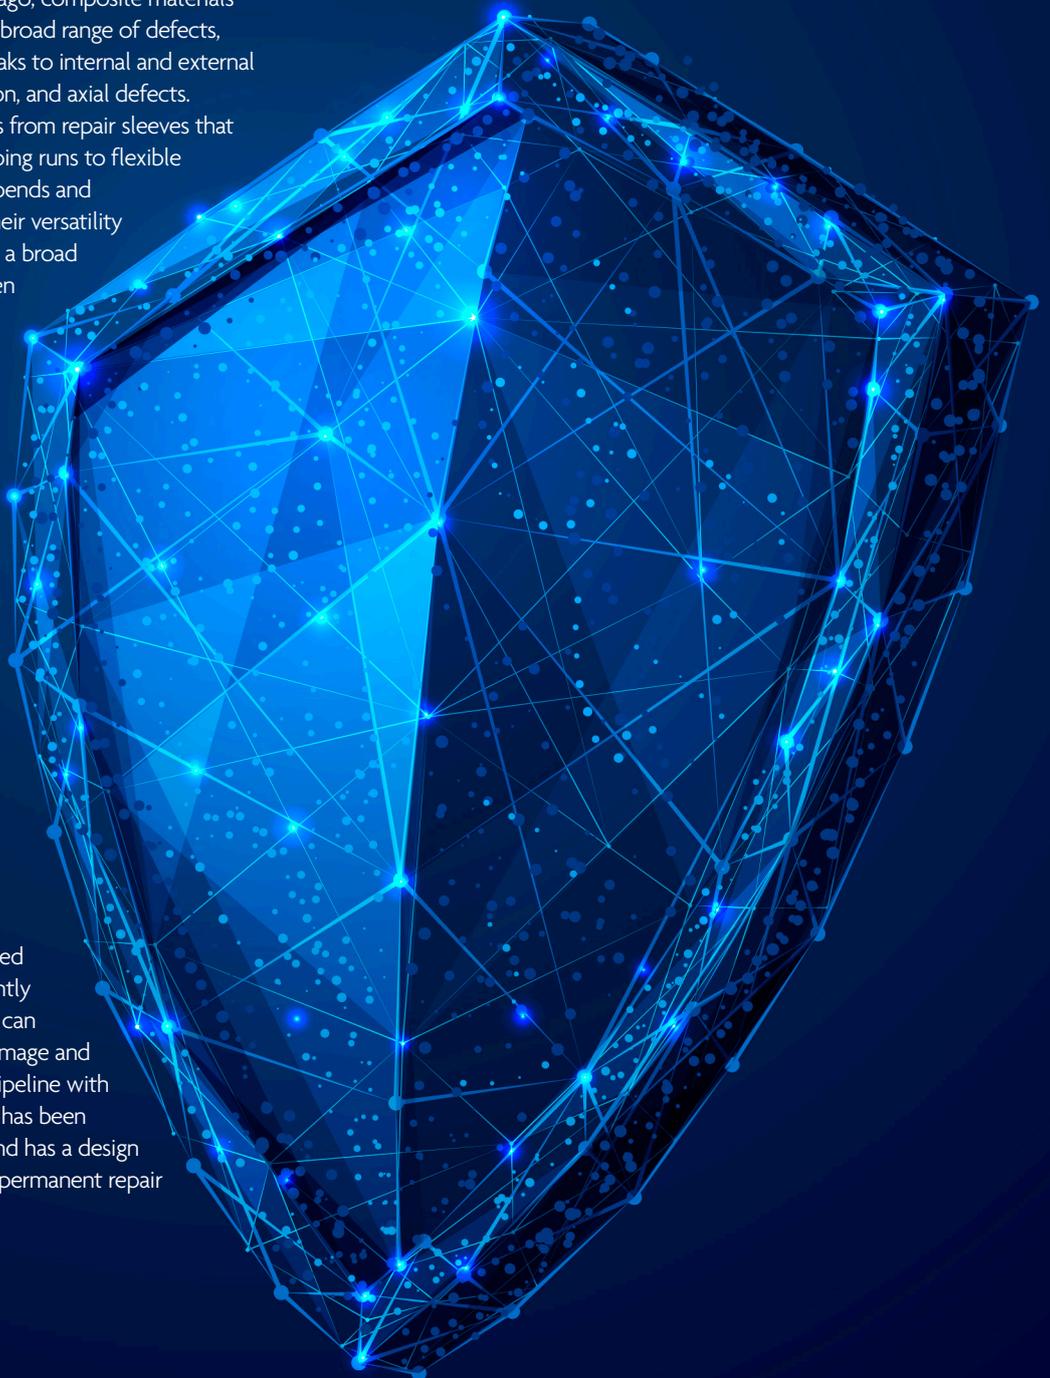
The Clock Spring coil is made up of eight layers of pretensioned unidirectional e-glass composite that is installed with a high-modulus filler material and a high lap-shear strength methyl methacrylate adhesive. Designed to structurally reinforce and permanently restore external anomalies, the sleeve can repair a broad range of mechanical damage and corrosion defects, and can restore a pipeline with up to 80% wall loss to full strength. It has been tested to 8000 psi internal pressure and has a design life beyond 50 years, qualifying it as a permanent repair by regulators around the world.

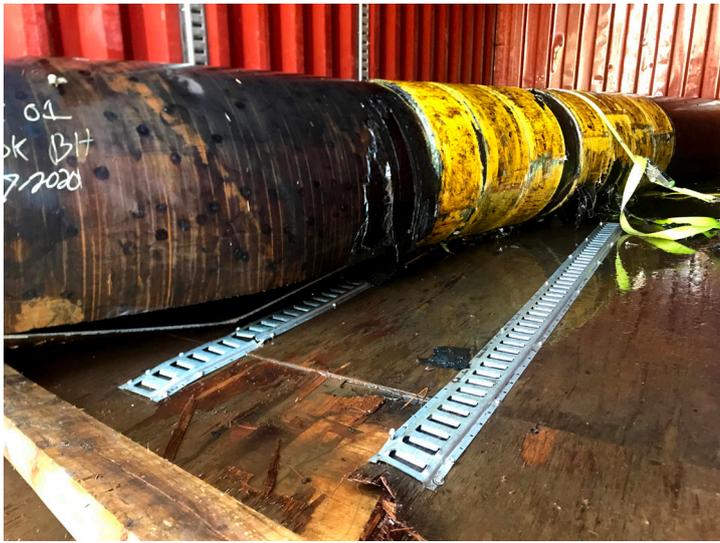
Figure 1. The testing programme for the 25-year old Clock Spring® repair was designed to gradually increase pressure to 1455 psi (100.3 bar), which is 1.5 times the MAOP of the pipeline, where the MAOP was 970 psi (66.9 bar). The composite repair showed no damage when the repaired pipeline section was pressurised to the target value of 1455 psi (100.3 bar) and held at that pressure for five minutes. (Photo courtesy of CSNRI).

Once the pipe section was received, it was fitted with end caps and fittings to conduct a full-scale pressure test. The testing programme was designed to gradually increase pressure to a target value of 1455 psi (100.3 bar), which is 1.5 times the MAOP of the pipeline, where the MAOP was 970 psi (66.9 bar). The repaired pipeline section was pressurised to 1455 psi (100.3 bar) and then held at that pressure for five minutes. After a successful hold at the target value, pressure was increased until the pipeline finally ruptured at 2180 psi (150.3 bar). It is noteworthy that the pipe ruptured not on the repaired section of pipe, but on a section of pipe outside of the repair area.

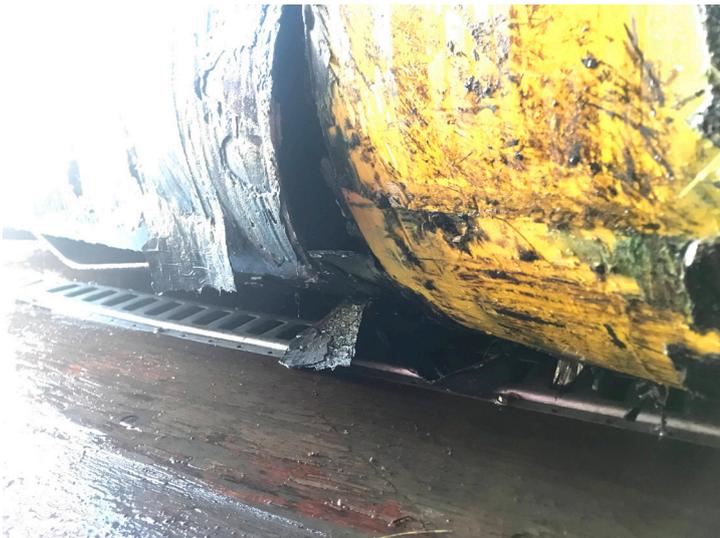
Figure 2. The repaired pipeline section was pressurised to and then held at that pressure for five minutes. After successfully holding the repaired pipeline section at the target value of 1455 psi (100.3 bar) for five minutes, pressure was increased until the pipeline finally ruptured at 2180 psi (150.3 bar). Interestingly, the rupture was not on the Clock Spring repair but on a section of pipe outside of the repair area. (Photo courtesy of CSNRI).
