RENEWWRAP®

Carbon Fiber Strengthening System

Case Study

FRP system to strengthen
concrete columns,
Colorado, U.S.

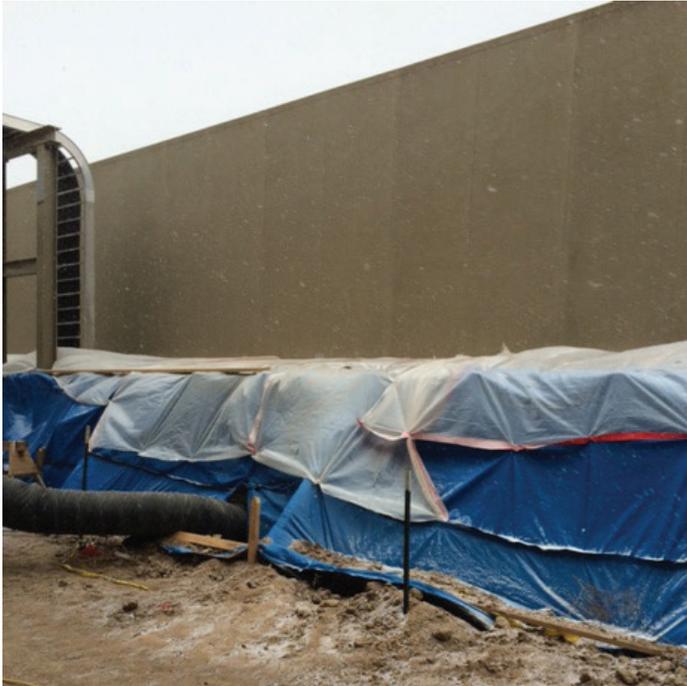
The columns were part of the construction of a new natural gas plant in Colorado

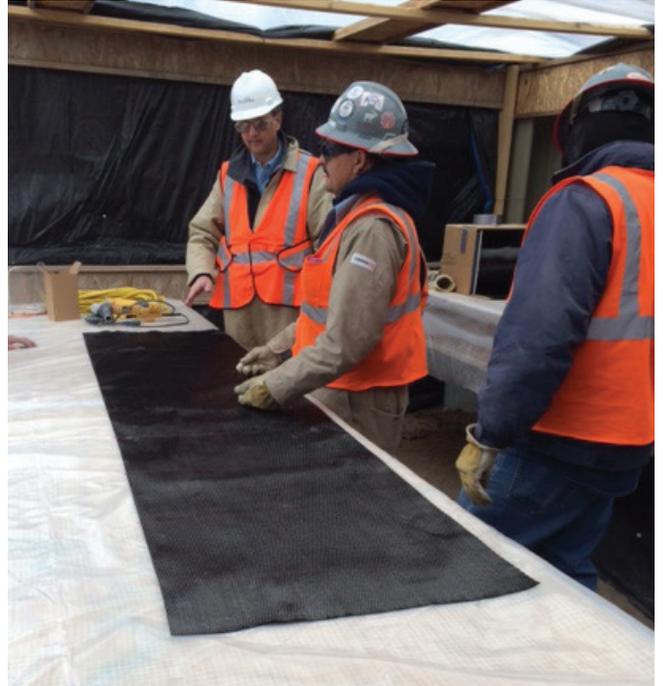
Preparing the fabric to install around the columns

GeoTree proposed a solution consisting of wrapping three layers of its RenewWrap carbon fiber strengthening system around the columns. The RenewWrap system consists of high-strength carbon fiber fabrics that are coated in the field with epoxy resins and bonded to the structure to strengthen the member being repaired.

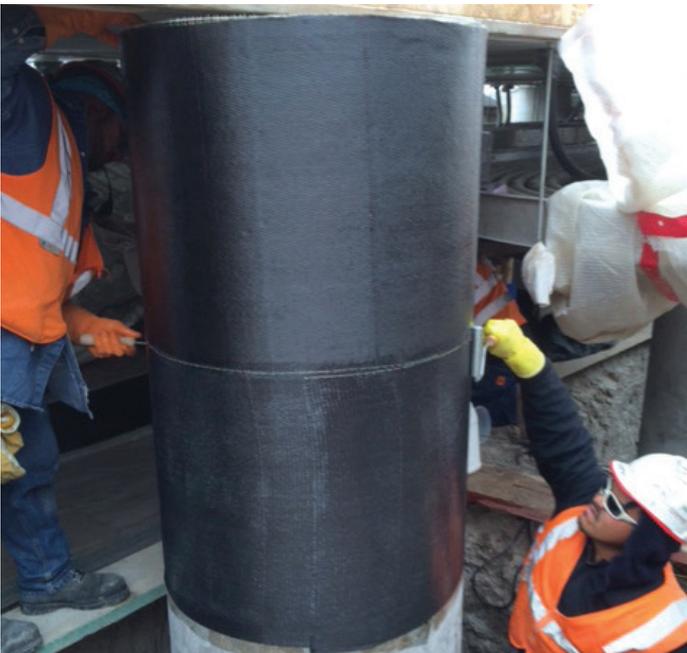
The wrap was covered with a UV-resistant coating

Thankfully, the construction team had anticipated the inclement weather beforehand and built temporary tenting around the exposed columns. The team also pumped in propane heat to elevate temperatures in the work area to 60 °F (15.5 °C) and kept backup heaters on stand-by. This was a critical component of the process, since the failure of any one heater would have compromised the FRP installation. The RenewWrap™ system was installed and coated with an UV-resistant paint within the two-week schedule.
