ThermoWrap™ MT Restores Corroded Hydrogen Sulfide Lines

SOUTH KOREA

Pipe Details

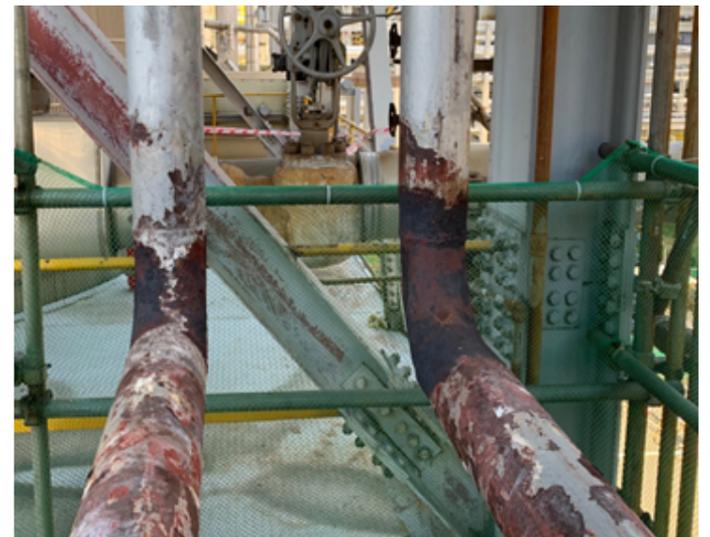
Corroded bends on two high-pressure, high-temperature hydrogen sulfide lines required immediate repair.

The refinery owner requested ThermoWrap® MT because of previous successes using the system for high-temperature, high-pressure (HPHT) repairs. ThermoWrap® MT is a custom engineered system that uses a fiberglass, composite-reinforced coating to restore corroded and damaged piping in HPHT conditions. Because it is a wrap, it can be applied easily to complex geometries like the corroded bends.

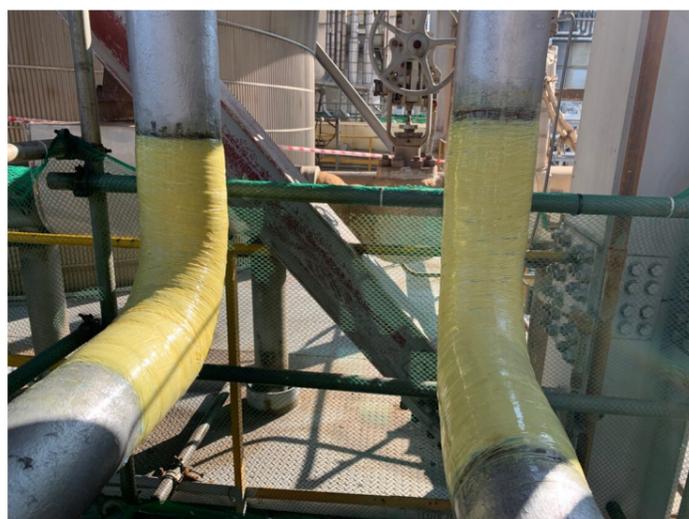
ThermoWrap® MT restored bends in corroded hydrogen sulfide lines, restoring the refinery to safety without interrupting operations

A team of 4 technicians mobilized to the site and prepared the surface of the corroded lines for the installation. When the lines were ready, they wrapped the 2 damaged sections – one 1.05 m (3.5 ft) long and one 0.75 m (2.5 ft) long – with ThermoWrap® MT, completing the entire installation in only 2 days.
