# Trenchless TECHNOLOGY

AUGUST 2021  
TRENCHLESSTECHNOLOGY.COM

# Geopolymer Lining

## Used For Kentucky Combined Sewer System

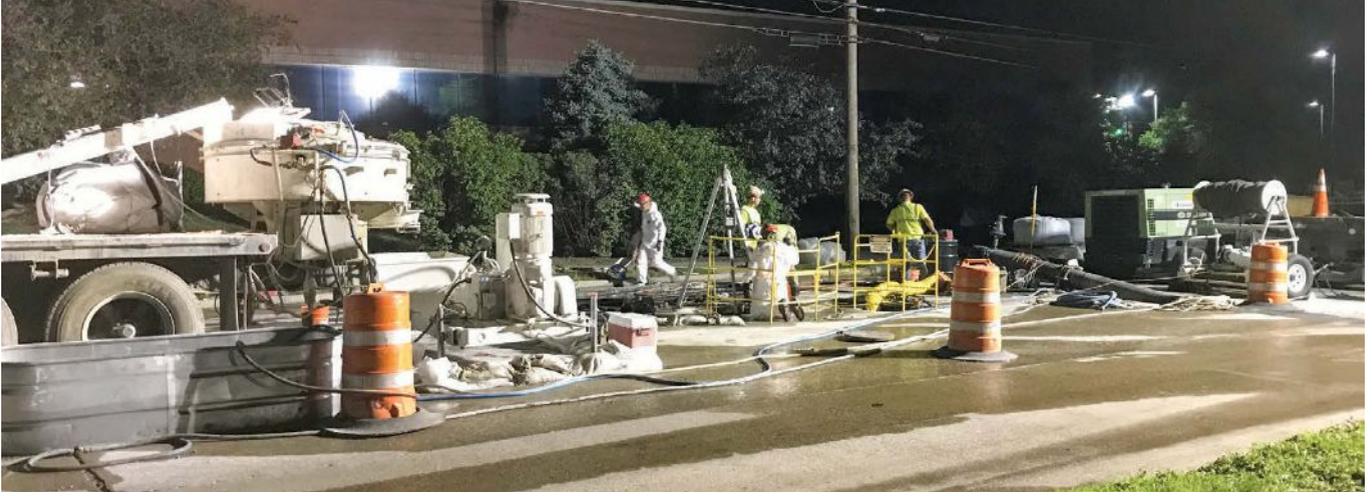
Even in ideal conditions, rehabilitating 1,400 ft of a 72-in. combination sewer with geopolymer mortar is challenging work for a crew experienced in using the sprayed-on material to restore the structural properties of a utility pipe. When real-world conditions are brought into play, that same project requires a contractor who understands precisely how to control conditions and apply material in the best manner possible to allow the work to be performed efficiently, safely and at a high level of quality.

Michels Corp. was contracted by the Regional Water Resource Agency of Owensboro/Daviess County (RWRA) to rehabilitate a combined sewer system it owns and operates in the Owensboro, Kentucky metropolitan area. Originally a 72-in. concrete pipe, multiple prior repairs resulted in the project consisting of 239 lf of 56-in. concrete pipe, 130 lf of 66-in. steel plate and 1,120 lf of 72-in. concrete pipe, changing diameter five times. The tunnel was located 50 ft below surface

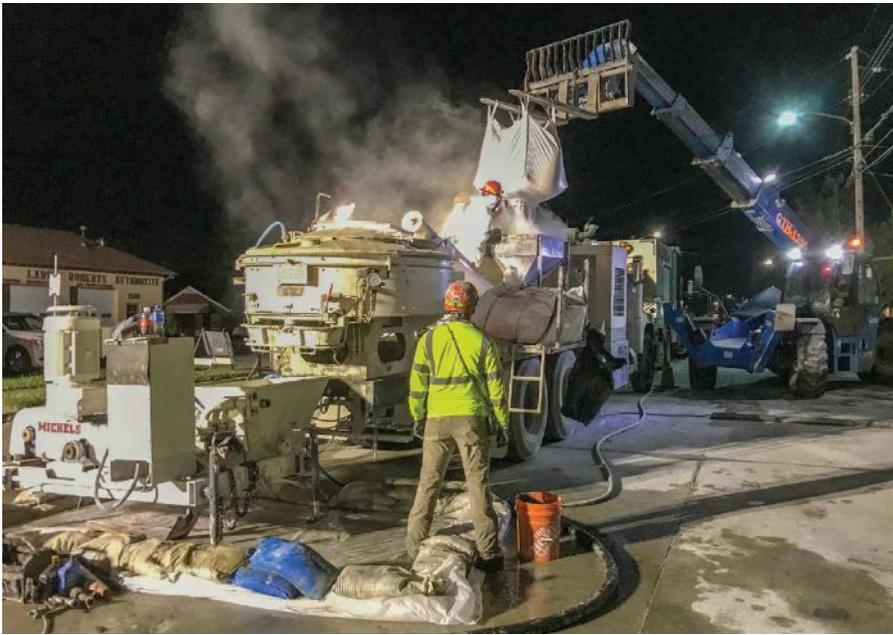
GeoSpray geopolymer mortar was selected for the spray-on application. Based on engineering calculations and design, the geopolymer mortar was sprayed on at different thicknesses throughout the project, including 1 ¾ inches in a 259-lf section of 56-in. concrete; 2 ¼ in. in a 1,122-lf section of 72-in. concrete tunnel;

and 3 in. in a 130-lf section of steel plated tunnel. In addition, the crew applied 1 in. in 50 vf manhole shaft, covering a total of 11,250 sq ft, and approximately 325 lf of geopolymer fill in the belly of the pipe. In total, 670,000 lbs of geopolymer mortar was applied on the project.
