Composite Repair Targeting CUI

Casey Whalen, *Global Engineering Manager at CSNRI*

VOLUME 27, ISSUE 4

JULY | AUGUST 2021

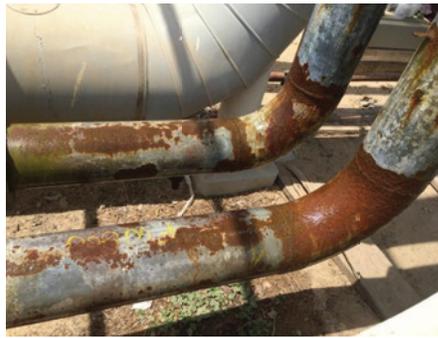
Figure 1. CUI was discovered in 38 areas on elbows, girth welds, vents, and drains on a 6-inch diameter pipeline carrying liquid styrene.

Reviewing a real-life application of a composite repair on CUI can demonstrate many of the benefits at once. In this case, a 6-inch, schedule 40 pipe carrying liquid styrene suffered extensive CUI over 38 distinct areas on the line. These areas included elbows, girth welds, vents, and drains with corrosion up to 50% of the pipe wall (**Figure 1**). Due to the complexity and quantity of CUI, the asset owner consulted a major composite repair provider for a solution. After assessing each defect area and the asset owner's allowable repair systems, an epoxy fiberglass composite repair system was used. Based on the defect severity and asset owner's desire, a 20-year design was engineered necessitating a seven-layer composite system.

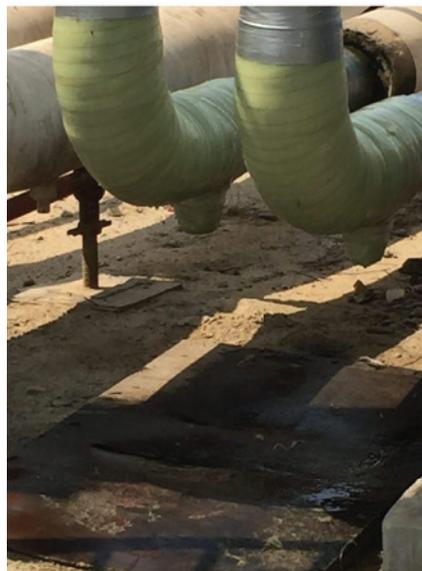
Figure 2. Using a composite repair solution allowed installers to restore the facility to safe operations with minimal equipment and manpower and without disrupting operations.

any contamination and then subsequently dried to remove any residual solvent and humidity. An appropriate amount of filler material was then applied to fill in the corrosion spots and restore a circular profile to the pipe. The primer layer was then applied followed by the seven-layer epoxy fiberglass composite repair system to provide the long-term structural integrity and corrosion protection required by the owner operator. Once completed, the repaired area could then be re-insulated with no further worry of corrosion in the repaired areas.

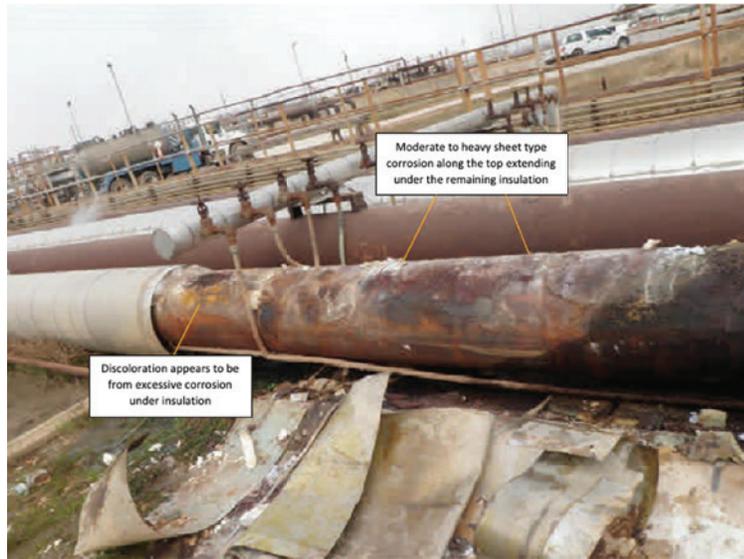
Figure 3. Insulation being stripped from length of 20” pipe

In another project which showcases the versatility of composites for CUI mitigation and repair, a refinery chose to wrap approximately 380 linear feet (116 linear meters) of a 20" diameter suction line. A section of insulation was removed due to an anomaly found on inspection data, which prompted the stripping of insulation from the length of the pipe. As the insulation removal continued, heavy-to-severe exfoliation type CUI was discovered along the entire top half of the piping. Scraping revealed lake-type pits throughout, up to 0.250" deep, with areas of pitting up to 0.300" deep. UT thickness readings with a pencil-type probe revealed a remaining wall thickness as low as 0.047" in some locations, which prompted the refinery to look into a structural option to repair and remediate.

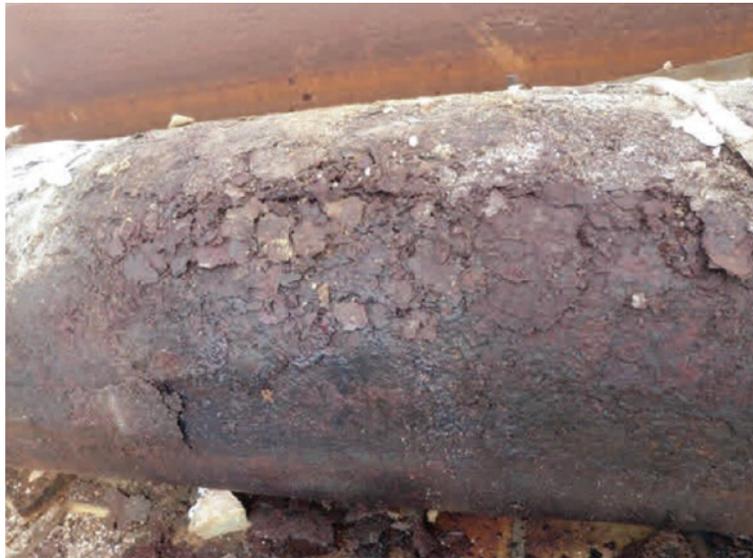
Figure 4. Close-up of heavy CUI damage
