**PROJECT PROFILE:
WATER LINE REPAIR
TYFO® SYSTEM**

EMERGENCY WATER LINE REPAIR FOR MAJOR UK POWER COMPANY

Location: Flintshire, North Wales UK

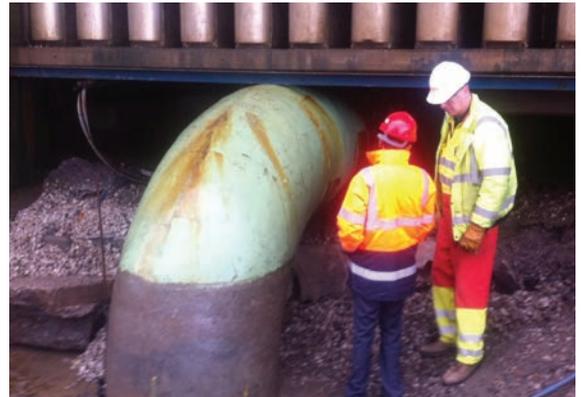
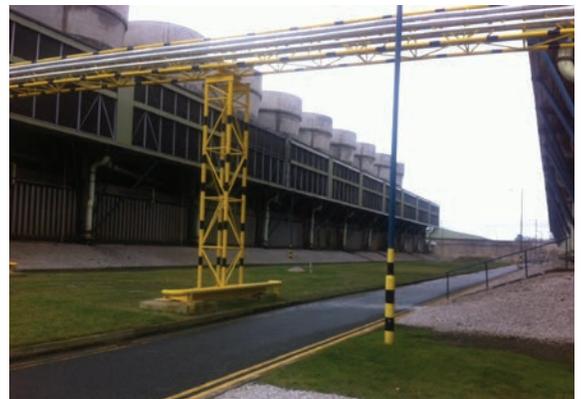
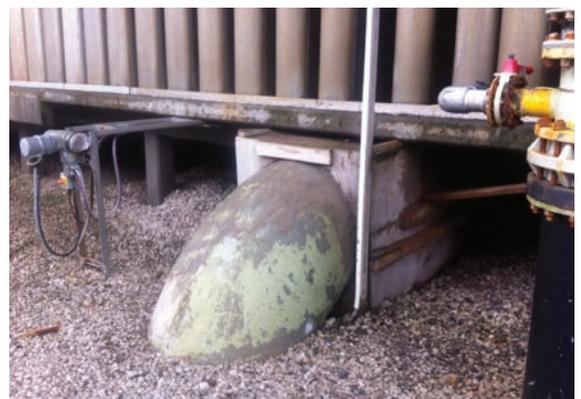
The company's design and maintenance team had carried out internal surveys of the lines and learned that the concrete encased steel pipes were corroded internally to a point where an exposed section of the pipe, that sat above the ground was at risk of failing.

The team understood that was a clear risk of failure if repairs were not immediate to the 900mm diameter cooling water lines. These lines are used to carry water from a nearby river to the condensers at the power plant.

The corrosion was likely caused by decades of continuous use; for large diameter pipes made from steel, ductile iron, or concrete, corrosion can lead to deterioration - threatening the structural integrity of the networks.

CCUK worked with E.ON's technical team to design an external composite wrap system that was able to take the full pressure of the line should a fail occur. Using a combination of bidirectional and unidirectional composite Fyfe FRP strengthening system, an emergency repair was carried out.

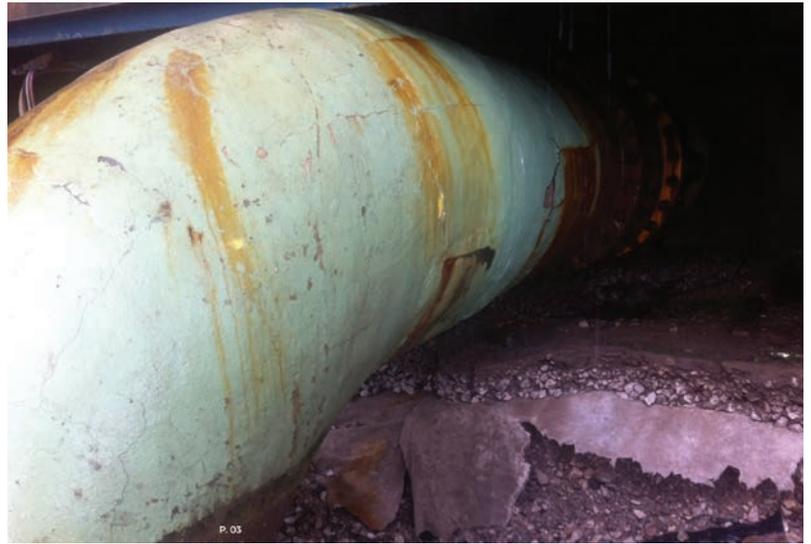
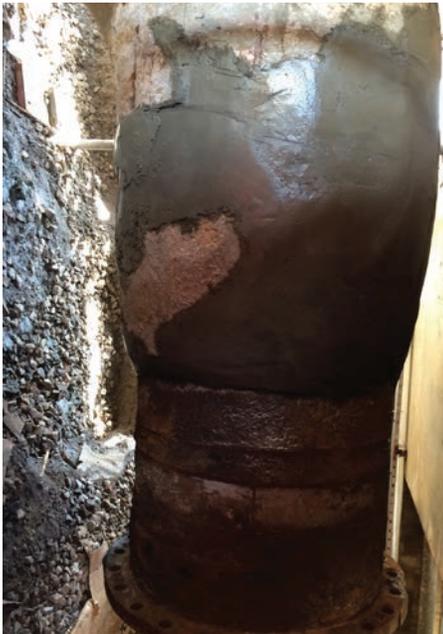
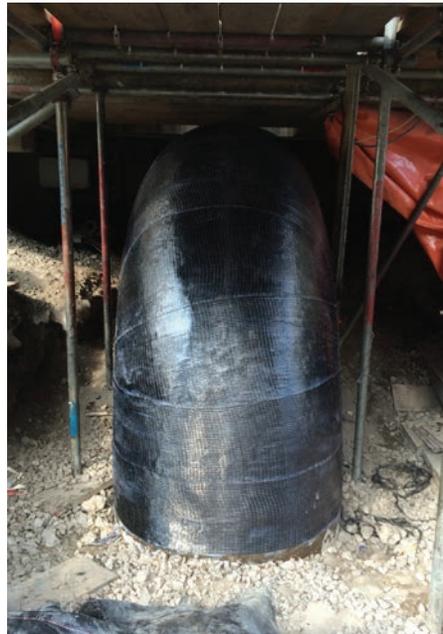
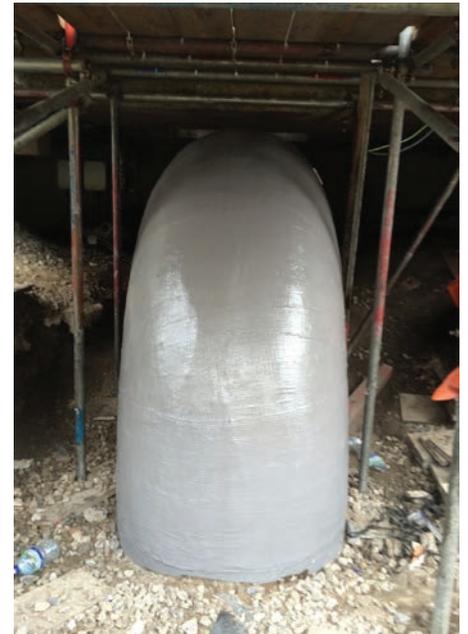
A section of the pipe was excavated to allow surface preparation including crack repair works to the host pipe and the formation of a smooth transition where pipe diameters reduced using specialist epoxy mortars. All works were carried out during planned shutdowns and each repair took days under reduced pressure without significantly affecting the running of the station.

The power station now has a fully encapsulated high pressure repair, complete with UV stable coating in place, that is designed to take the full water pressure within the line.
