Pipe Support Provides Rope Access Solution for Corrosion Repair and Pipe Protection

Belgium

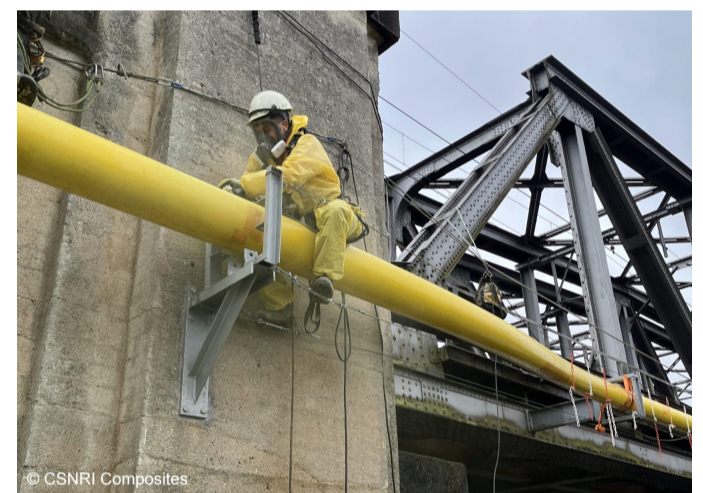
Before Pipe Support Installation

A Belgian-based pipeline owner conducting a scheduled inspection found areas of severe atmospheric corrosion at support locations on an above-ground 10" carbon steel pipeline. The pipeline coating was otherwise in good condition in non-contact areas. Following a proactive maintenance protocol, the owners looked for a solution that would restore the integrity of the pipe at support locations, prevent further corrosion, and minimize the possibility of emergency repairs that might result in interruption of operations. Interseal, a CSNRI distributor and installer located in Belgium, proposed CSNRI'S [Pipe Support](#) composite mechanical protection system. Pipe Support provides both a preventative and rehabilitative maintenance solution that protects and extends the life of the pipe.

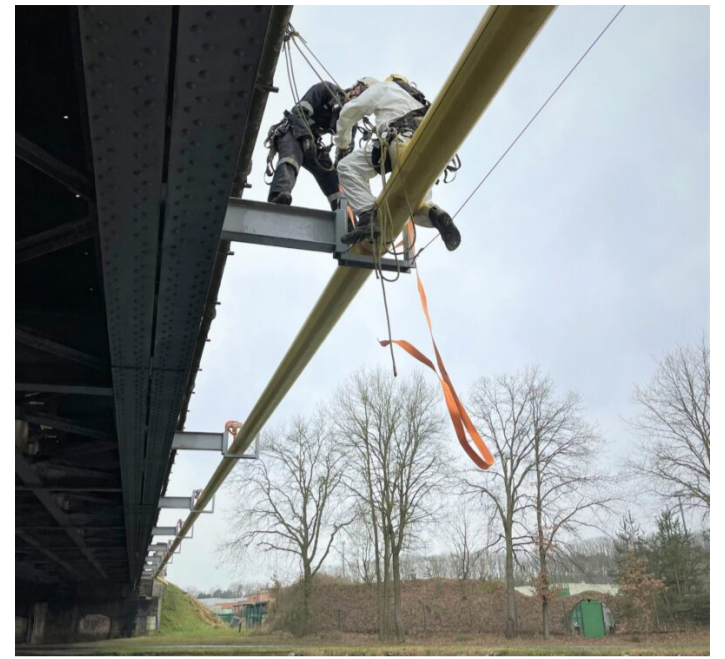
The repair area was accessed through a system of ropes and harnesses that lowered the crew to the pipe location.

It was not possible to position scaffolding to complete the installation. Instead, a level 3 RA team from a local vendor provided a rope and harness access system to facilitate the repair. The vendor trained the Interseal crew in the use of the system to ensure safe access to the areas requiring repair, allowing Interseal to complete the necessary work to restore the damaged areas of the pipe.

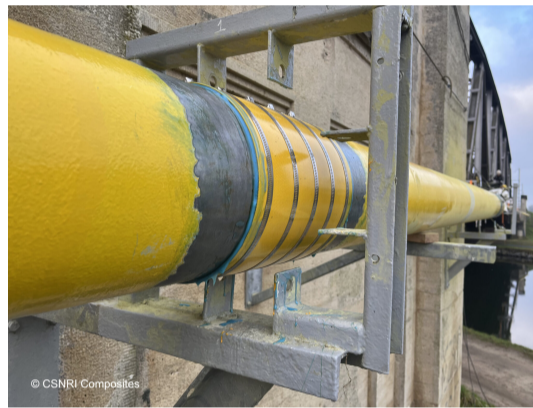
The Pipe Support system creates a non-corrosive environment where the pipe comes into contact with the support, repairing defects and providing protection against future damage.

To install the repair, the Interseal crew first prepared the pipe with an MBX® bristle blaster to remove the existing pipe coating and provide the required anchor profile. To repair corrosion-damaged areas identified during inspection, Pipe Support fiberglass composite sleeves were installed directly over the defects with high-performance adhesive and filler material that permanently bonds the system to the pipe. Pipe Support was also installed at locations without signs of corrosion to protect the pipe against further defects. The system was installed by a crew of two over the course of five days, with installations at three to four locations per day, for a total of 14 installations. The repairs required 14 kits, with each kit including two layers of materials.

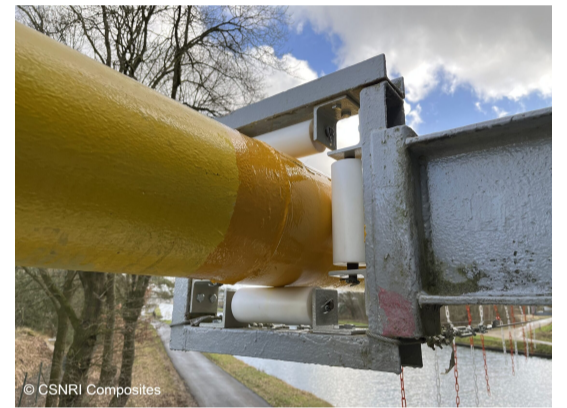
Once the system fully cured the retaining clips were removed and the existing coating extended over any surface preparation. New Pipe Support contact point rollers were also installed.
