## **REPAIR AND RETROFIT OF CORRODED BEAMS, SLABS & COLUMNS**

Location: Redondo Beach, CA

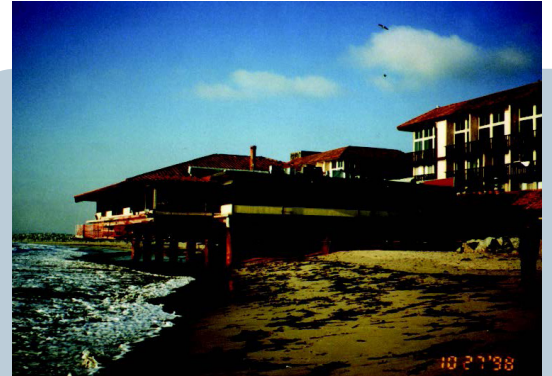
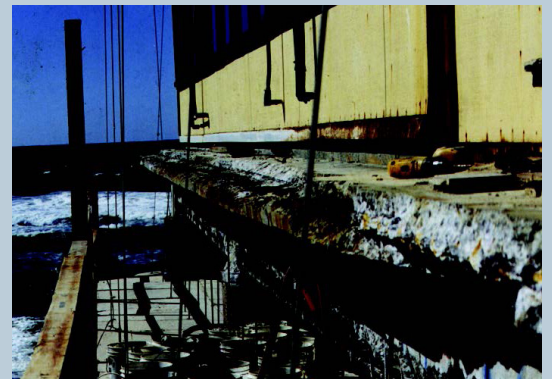
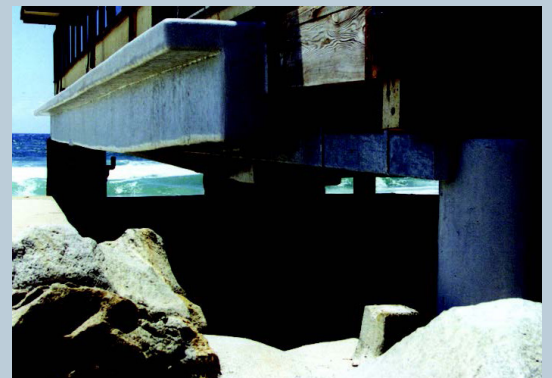
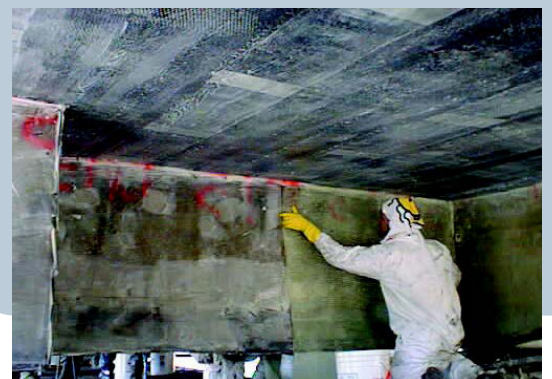
An upscale restaurant and adjoining apartment complex, which was in poor condition structurally and aesthetically mostly due to exposure to marine weather conditions was in dire need of structural rehabilitation. The restaurant actually sets out into the ocean on concrete pilings and ocean surf is continually surging up against the bottom of the restaurant's floor. The city required a permanent repair of corrosion damage to pilings, beams and slab or the restaurant would have to be demolished.

The severe deterioration of pilings, beams and slab required a phased retrofit, which would include the strengthening of specific areas and sealing the entire underside of the restaurant.

A suspended platform was constructed to provide working space for the crew, and at the same time, protect the beams and slab from the ocean surge. A process of discovery was initiated to remove unsound concrete. After treatment with a corrosive inhibitor system, the exposed steel and surrounding concrete was sandblasted. Polymer-modified concrete was then applied to reform members to their original shape. The LOCTITE SEH glass and SCH Carbon systems were applied to strengthen the pilings, beams and slab to regain their original capacity. A final application of LOCTITE WEB was applied as a water sealant and protection from the environment.
