GeoTree and Structures, Inc work together on bridge strengthening project

Location: La Junta, Colorado

Application: Flexural and Shear Strengthening of Pier Caps and Pier Columns.

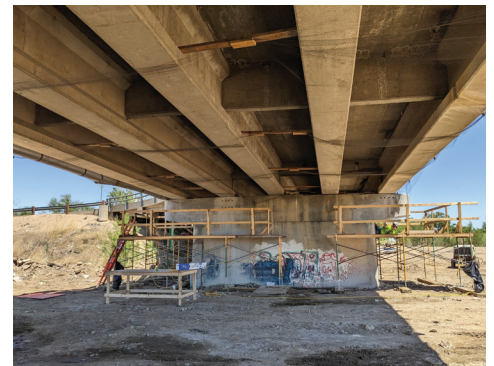
Scaffolding in place to enable pier access.

Scaffold platforms were constructed around each pier to enable the contractors to have full access to the required areas and also to ensure they were out of the water flowing under the bridge. In areas too high for scaffolding, a cherry picker was used during low river flow opportunities.

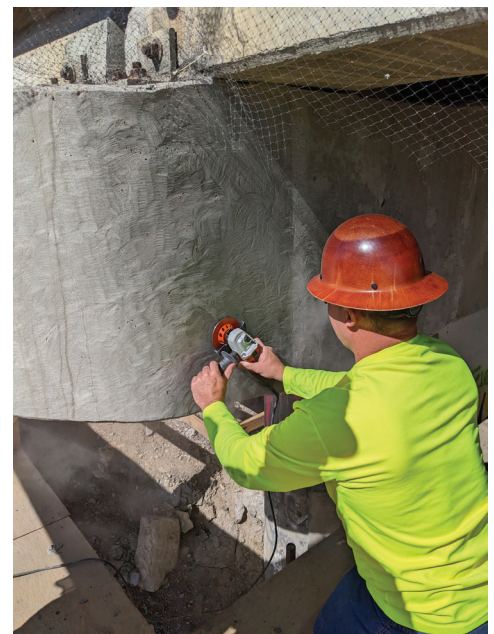
Surface preparation.

The piers were then prepared for the FRP application with surface corrosion removed.

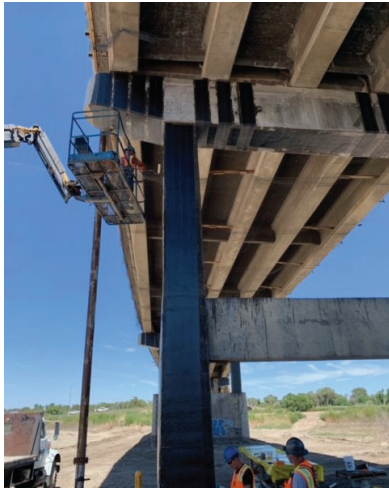
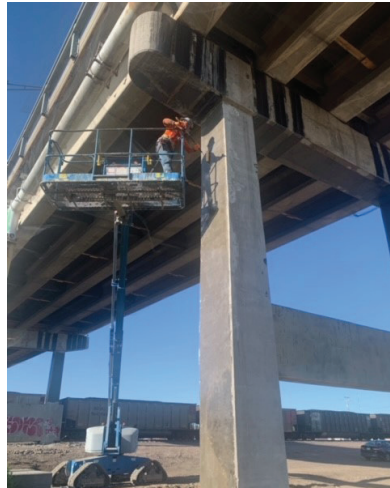
Cherry picker used to apply FRP at height.

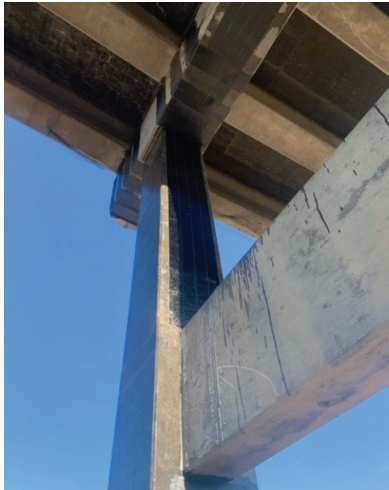
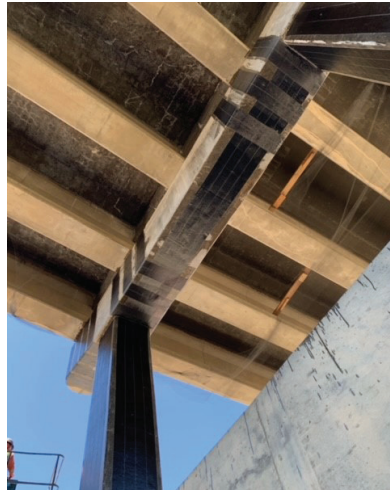
Completed application of RenewWrap FRP.

The project scope called for the application of two layers of RenewWrap CF600 4x6 carbon fiber fabric system which was saturated with RenewWrap LPL Saturant. EZ Paste epoxy was used to level the surface of the concrete substrate and fill any small voids and bug holes. Three-sided U-wraps were applied to the pier caps for shear strengthening. Longitudinal wraps were applied to the bottom and tops of pier caps for flexural strengthening. And vertical wraps were applied on each face of the pier columns for flexural strengthening.

The RenewWrap was applied using the wet layup method, which sees the FRP fabric saturated with epoxy while laid on a table. It is then transferred to the concrete and securely fitted in place following engineer drawings.
